THE RESTORATION OF THE MONUMENTS OF THE ATHENIAN ACROPOLIS

MINISTRY OF CULTURE AND TOURISM - ACROPOLIS RESTORATION SERVICE

2nd Edition (updated with the restotation programme 2011-2013)

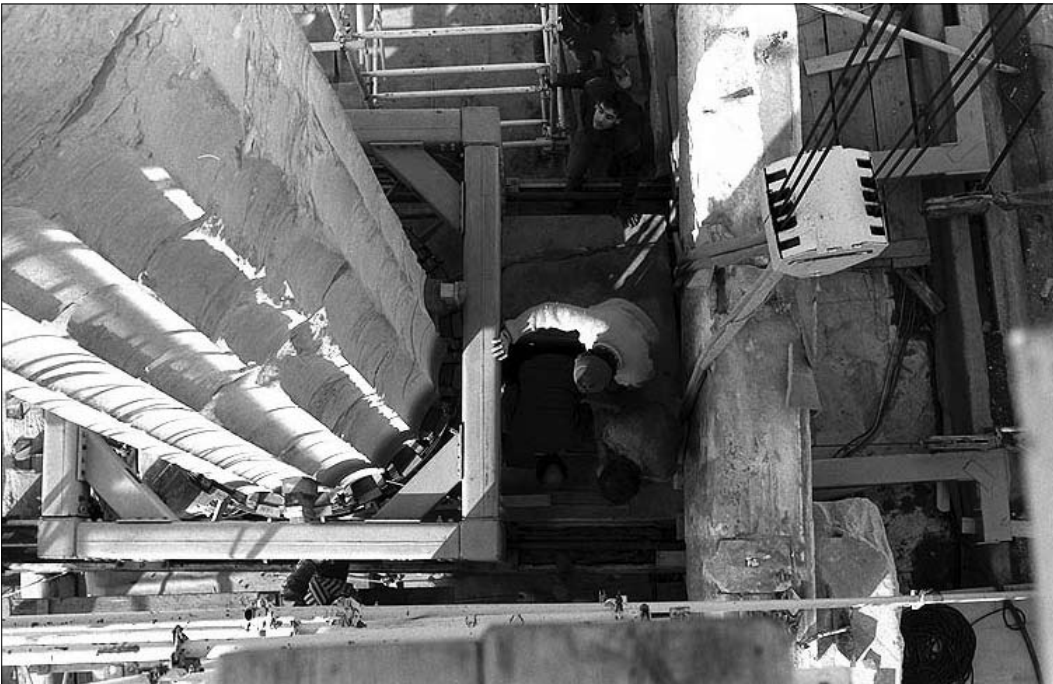
4

4. Intervention on the 5th from the east column of the south colonnade of the Parthenon.

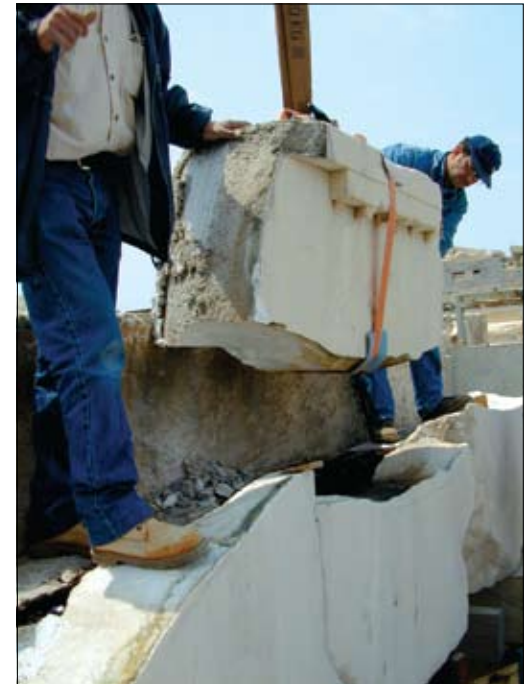
6. *Dismantling a fractured architrave block of the north side of the Parthenon.*

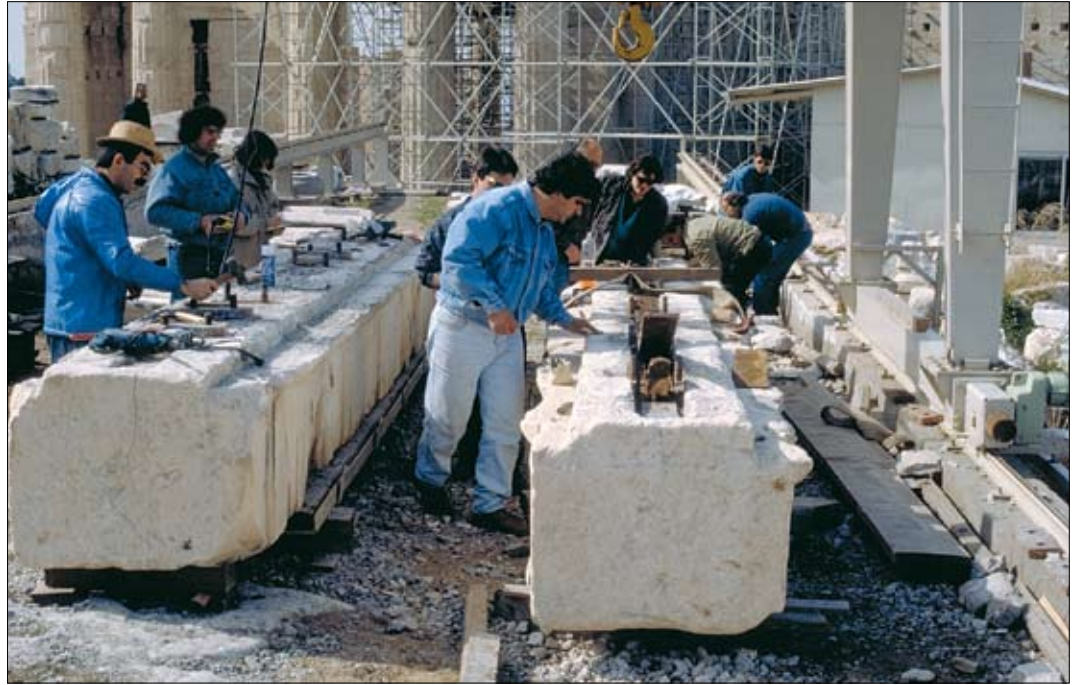
7

7. *Removal of iron reinforcement from Propylaea beams.*

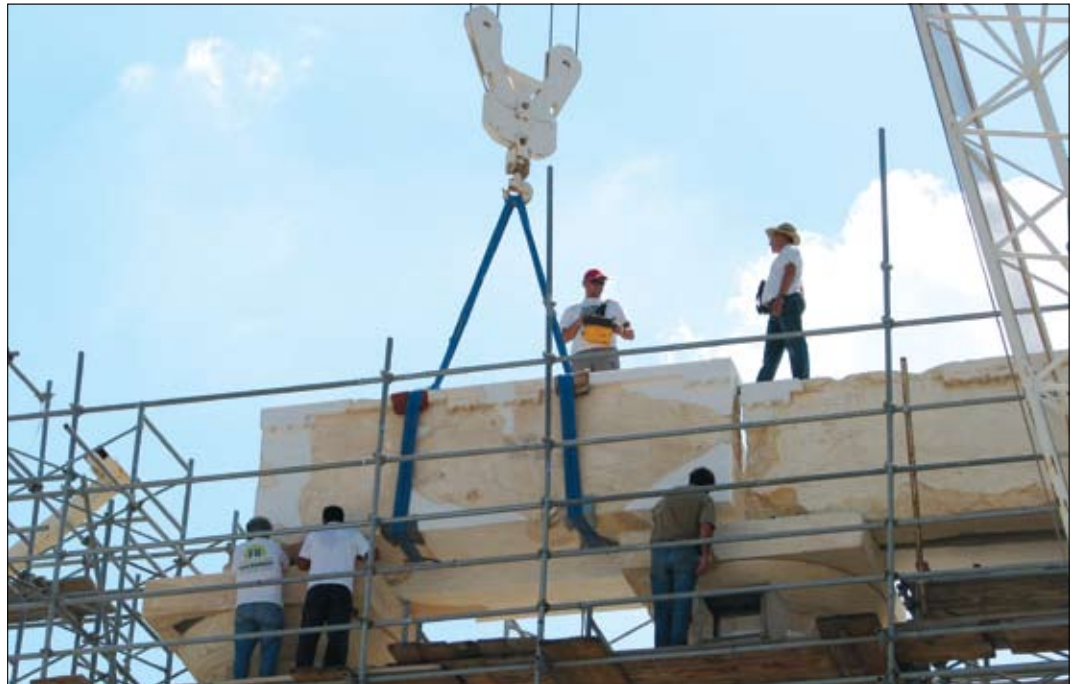
8

8. *Setting an architrave block of the north side of the Parthenon.*

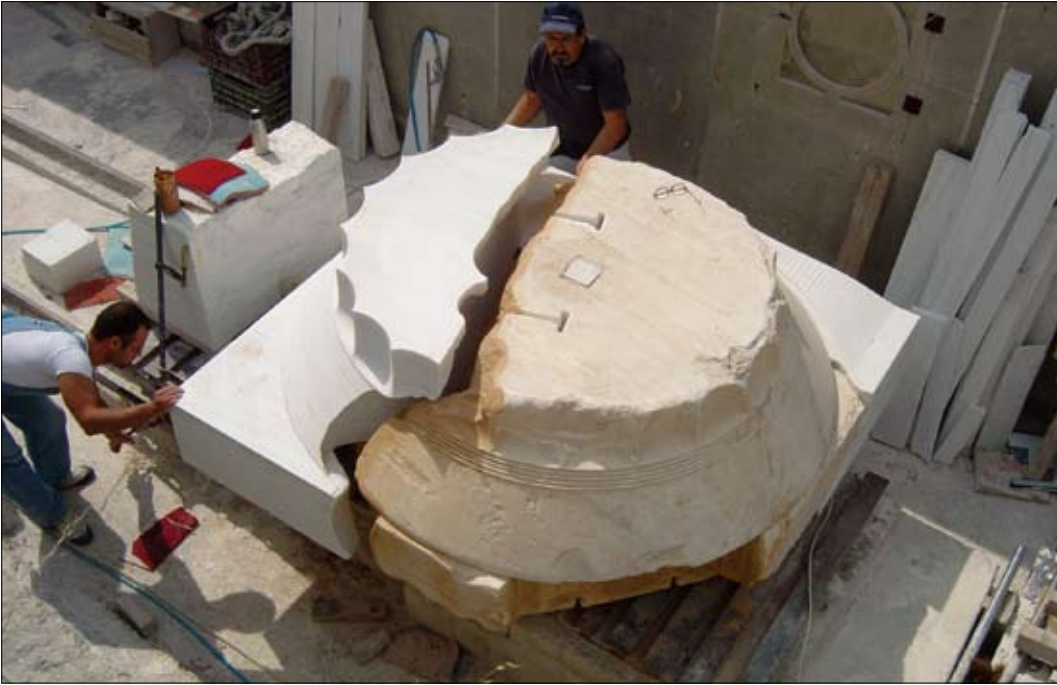
9

9. Fitting a new marble filling to a column capital of the north colonnade of the Parthenon.

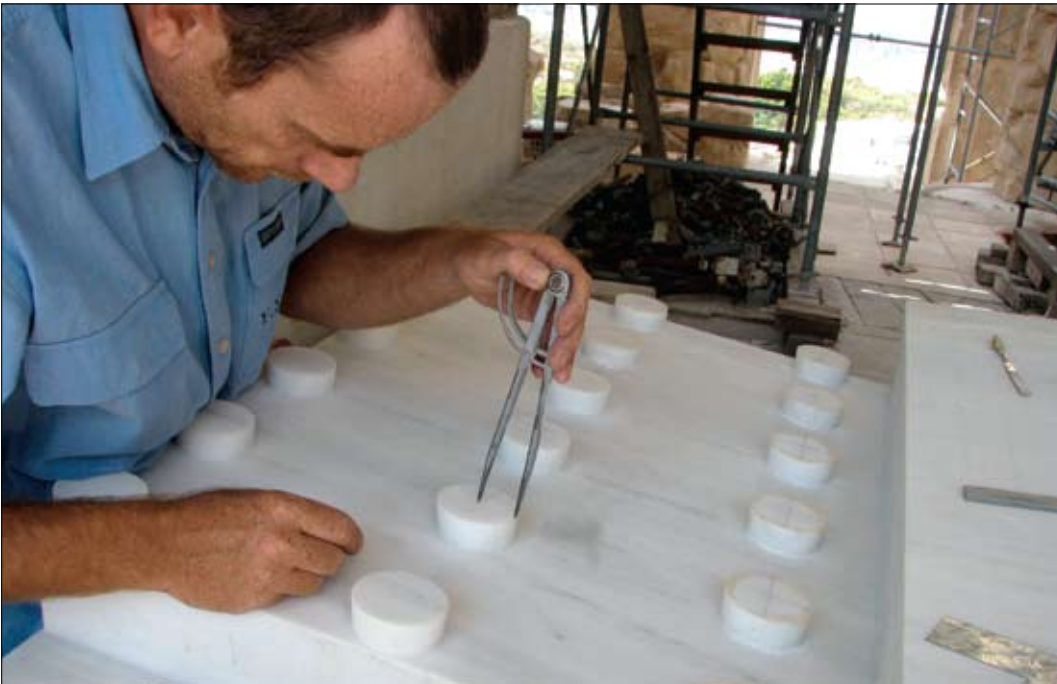
11

11. Carving the guttae on a cornice filling of new marble for the north side of the Parthenon.

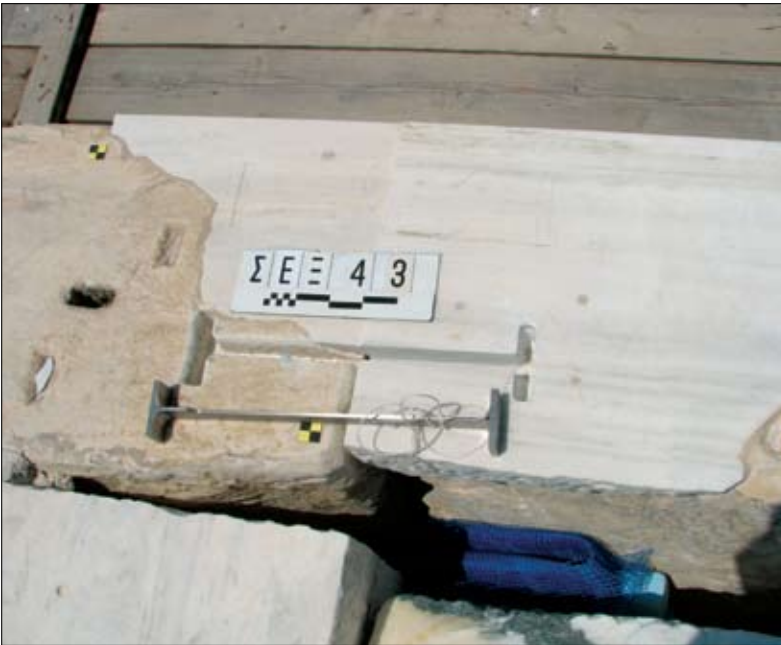
12. Setting a double-T clamp of titanium for joining two architrave blocks in the north side of the Parthenon.

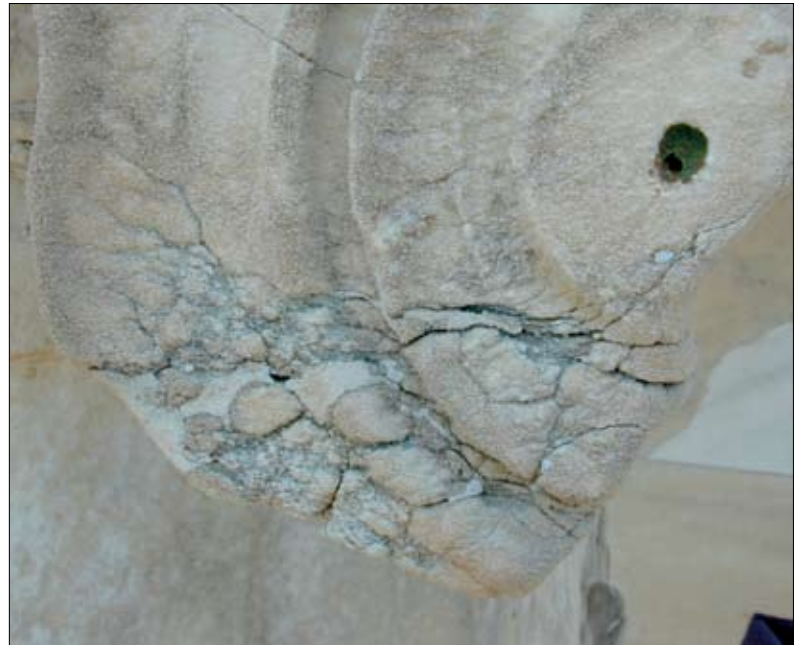
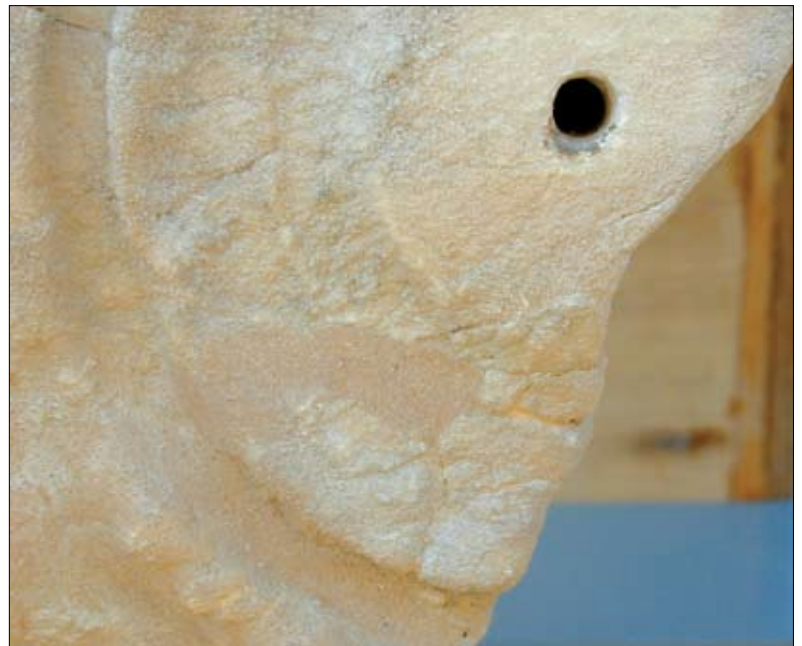
13a-b. Column capital of the east porch of the Erechtheion. Condition of the surface before and after conservation.

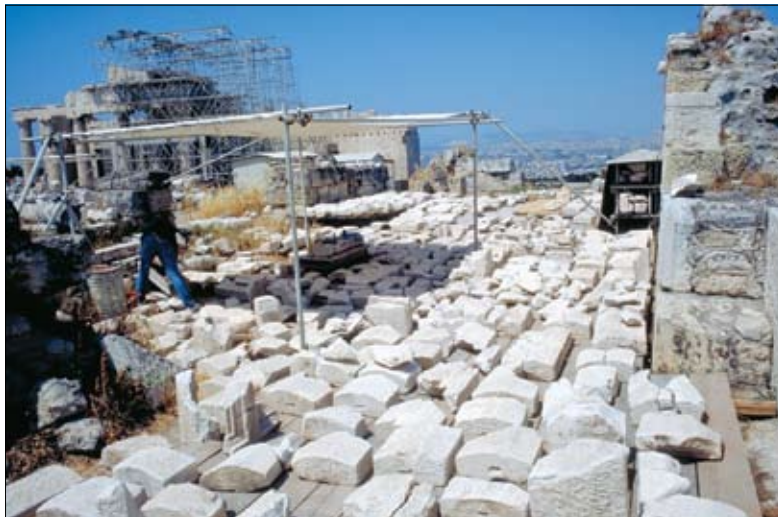
49

49. Fragments of the coffered slabs identified during research in the Propylaea worksite.

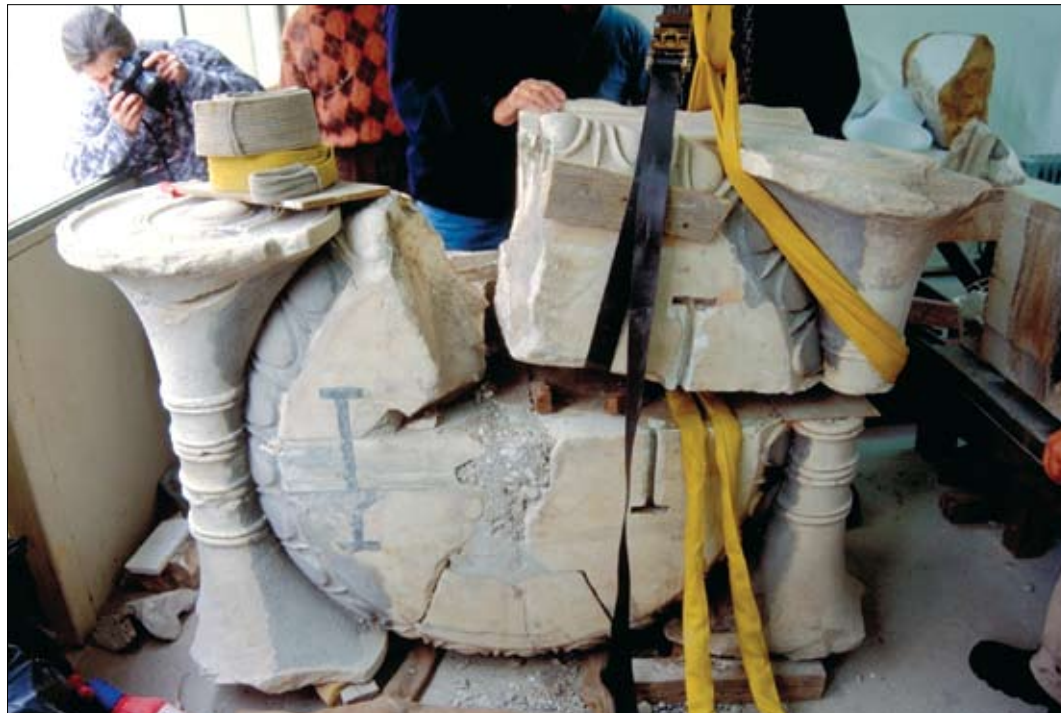
50. Dismantling the column capital of the Balanos anastelosis in the Propylaea laboratory.
