# THE RESTORATION OF THE MONUMENTS OF THE ATHENIAN ACROPOLIS

Publisher  
ACROPOLIS RESTORATION SERVICE

2nd Edition (updated with the restotation programme of 2011-2013)

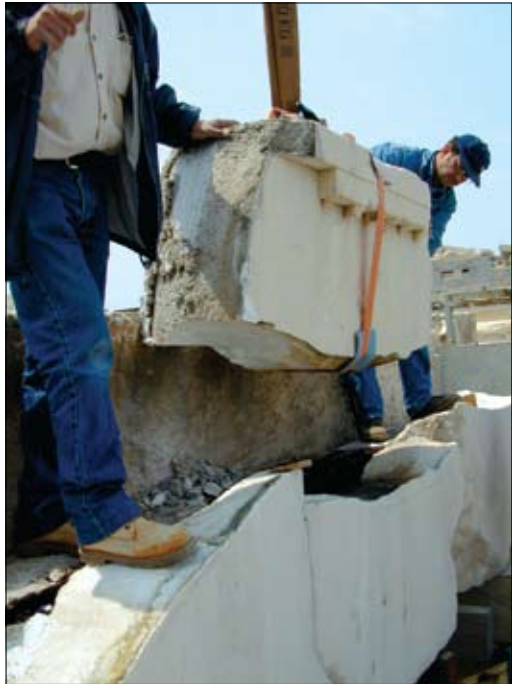
6

6. Dismantling a fractured architrave block of the north side of the Parthenon.

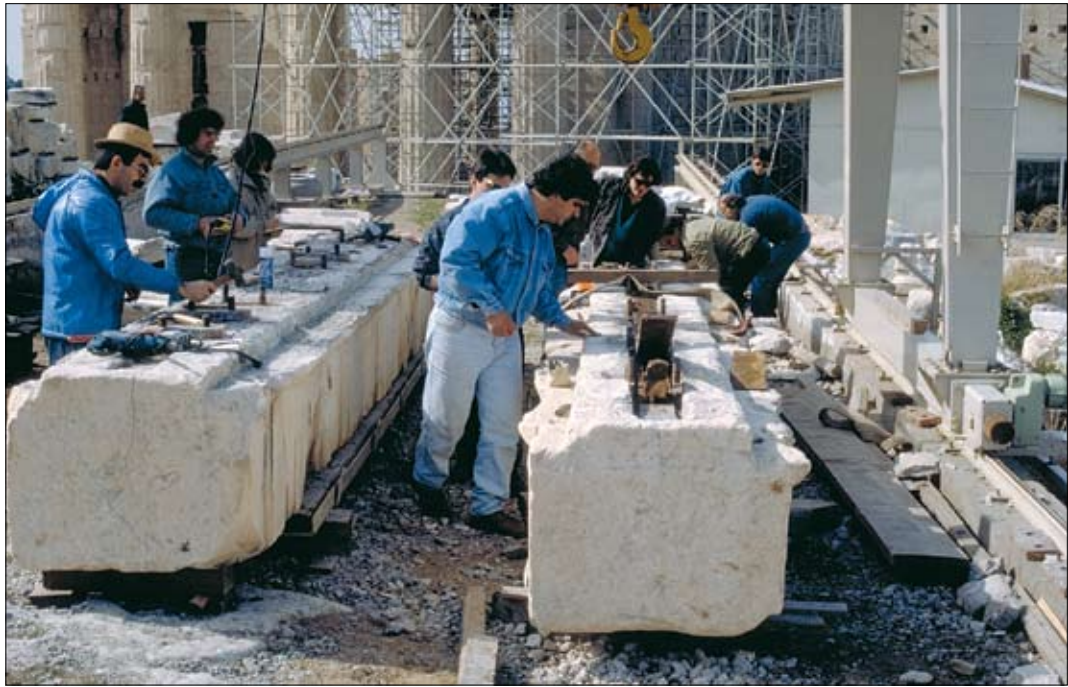
7

7. Removal of iron reinforcement from Propylaea beams.

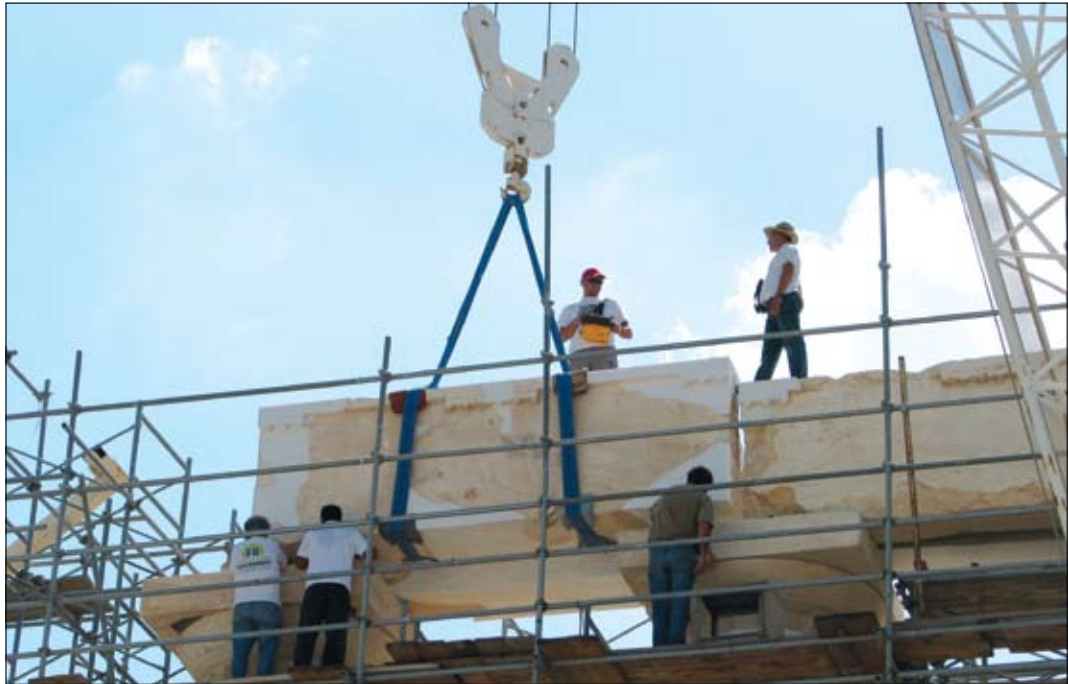
8

8. Setting an architrave block of the north side of the Parthenon.

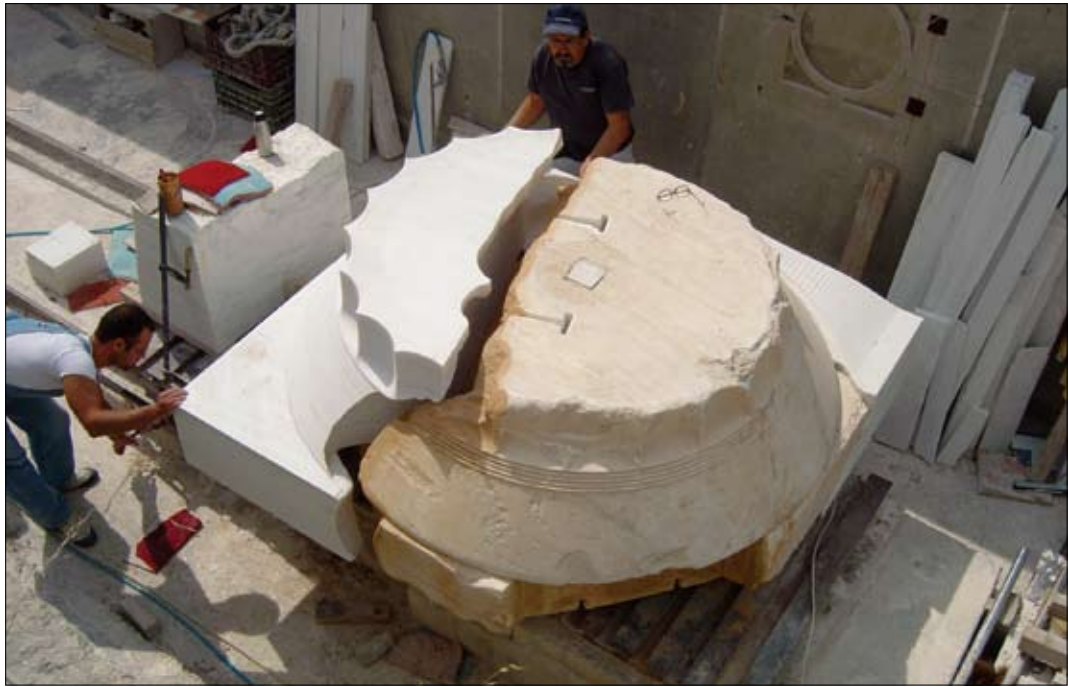
9

9. Fitting a new marble filling to a column capital of the north colonnade of the Parthenon.

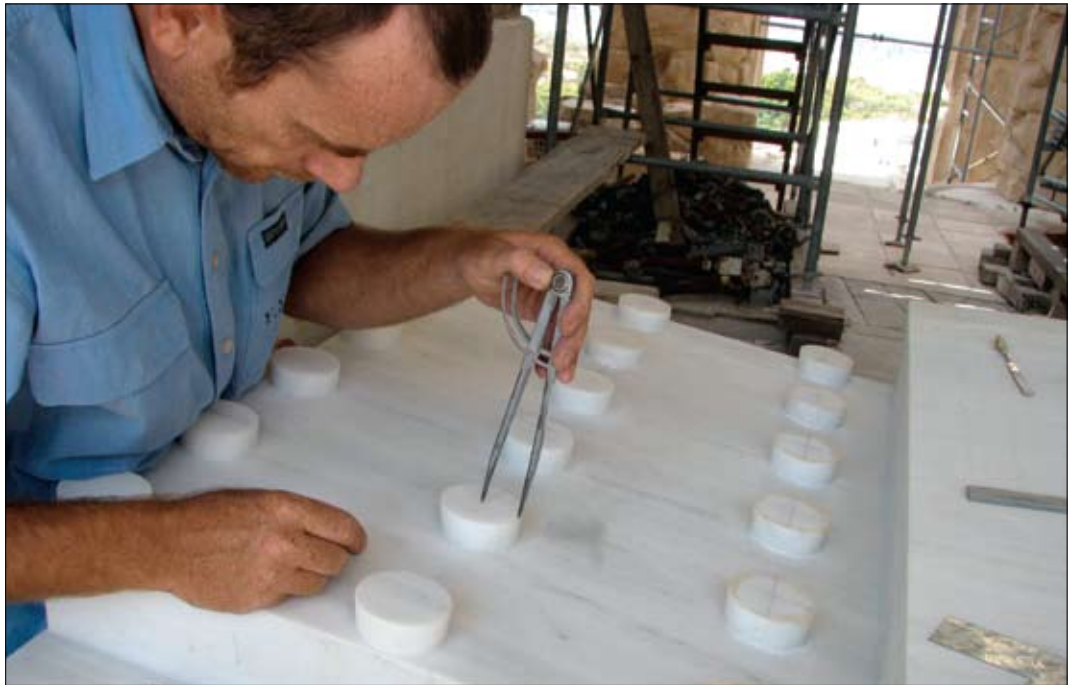
11

11. Carving the guttae on a cornice filling of new marble for the north side of the Parthenon.

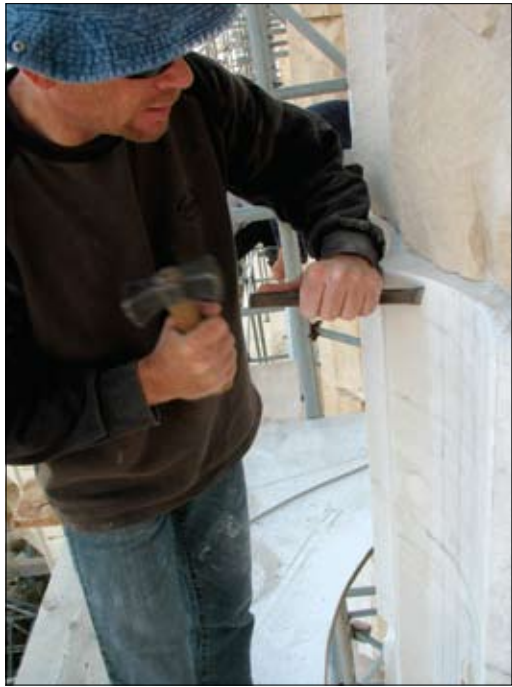
10

10. Final cutting of the flutes on a filling in a drum from the north colonnade of the Parthenon.

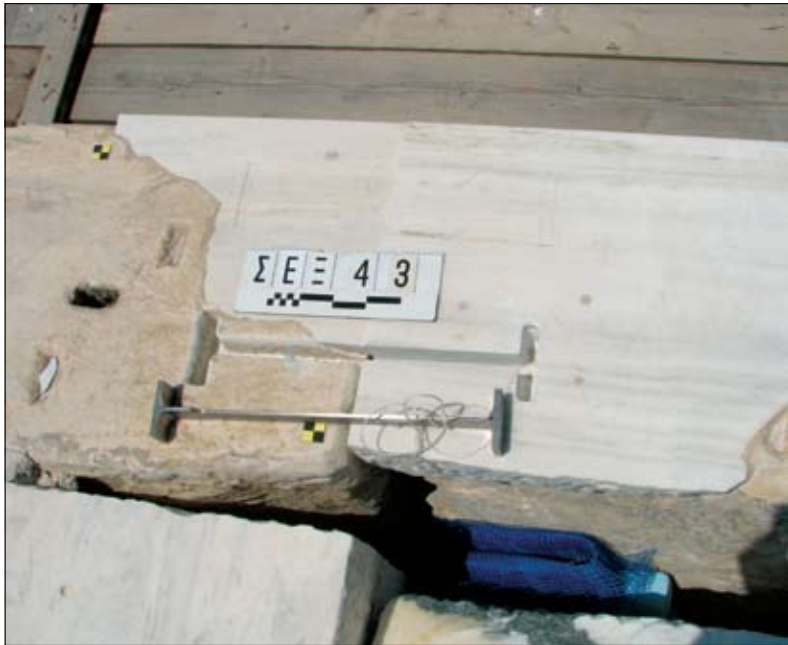
12. Setting a double-T clamp of titanium for joining two architrave blocks in the north side of the Parthenon.

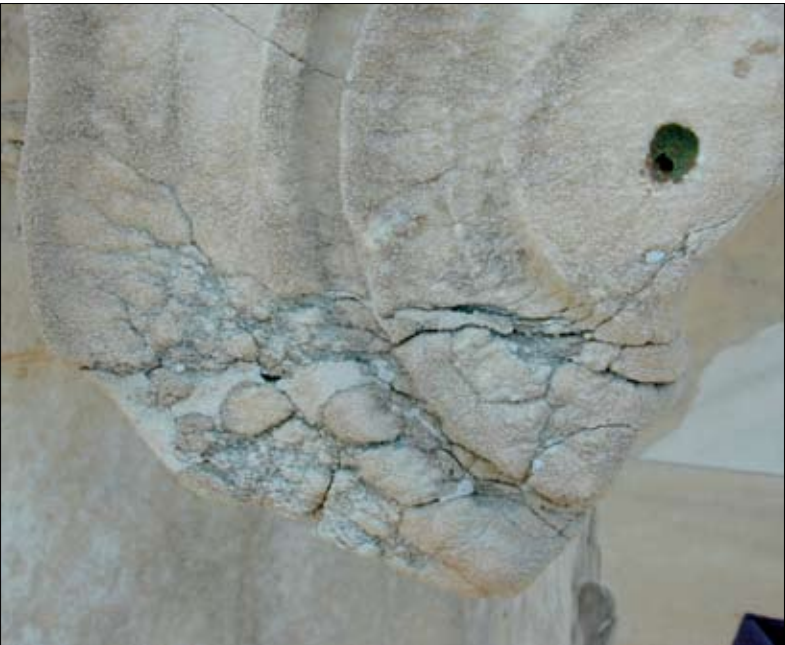
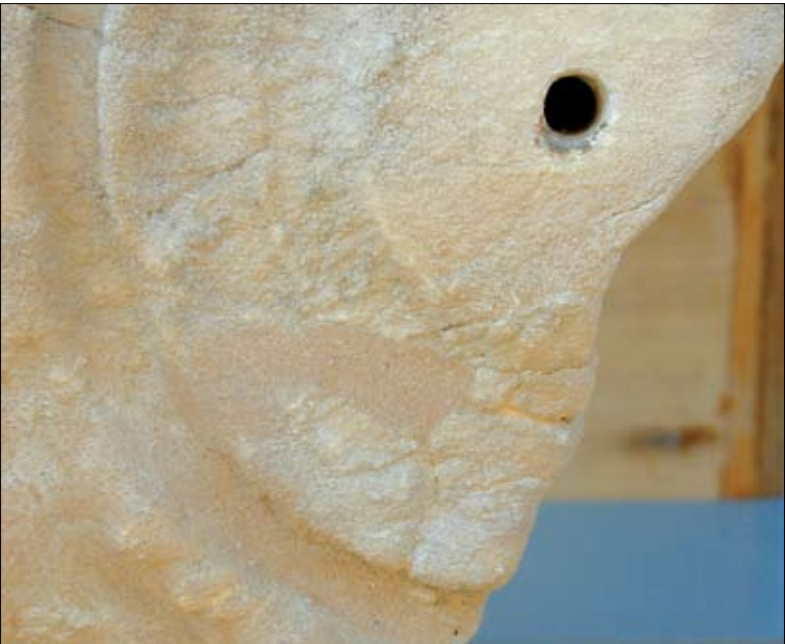
13a-b. Column capital of the east porch of the Erechtheion. Condition of the surface before and after conservation.

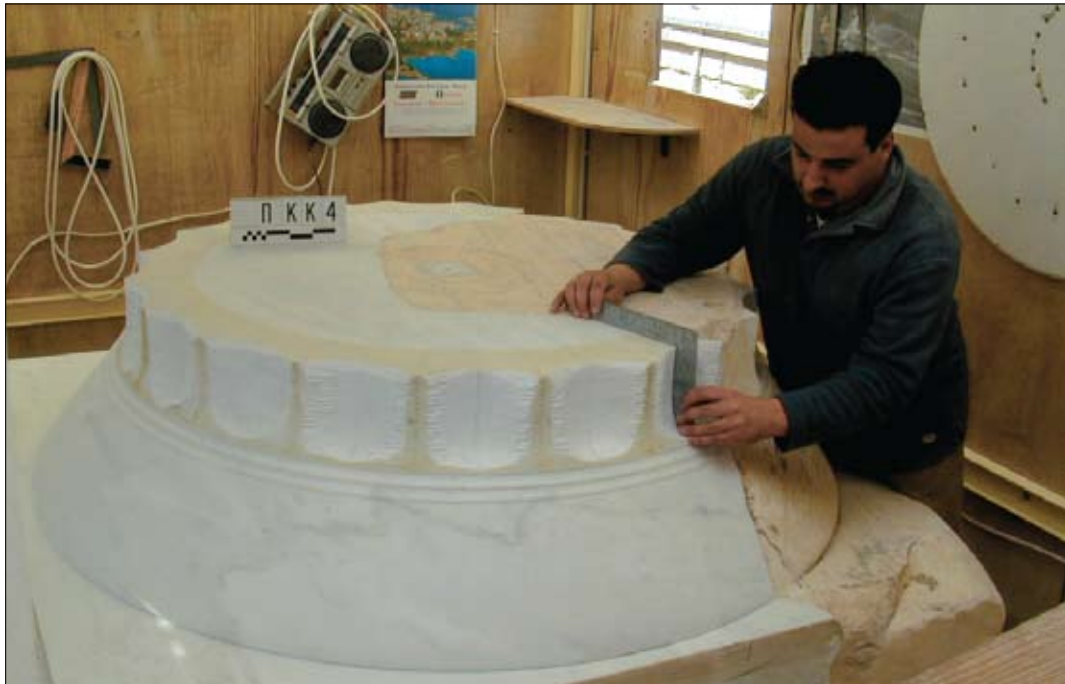
22

21. Working on the upper resting surface of a new filling in a drum of the Parthenon pronaos.

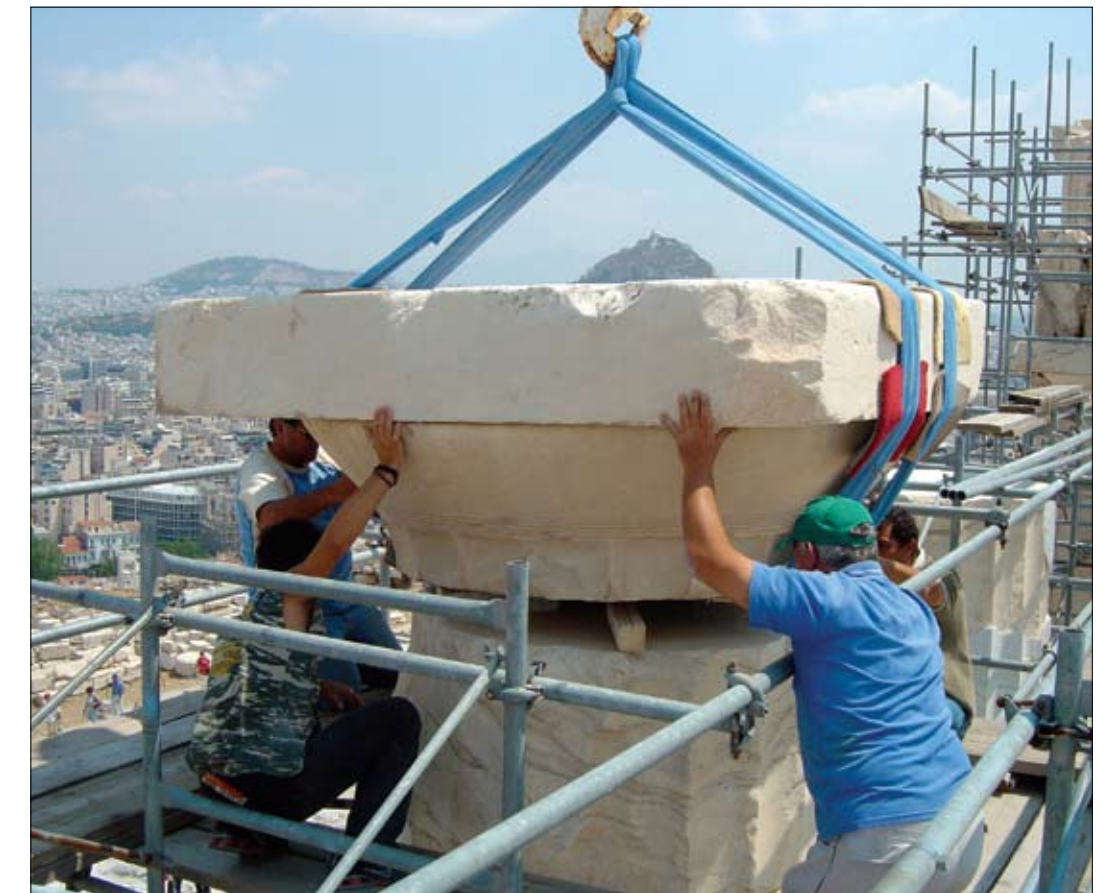
35. Parthenon. Resetting of an ancient column capital of the north colonnade.

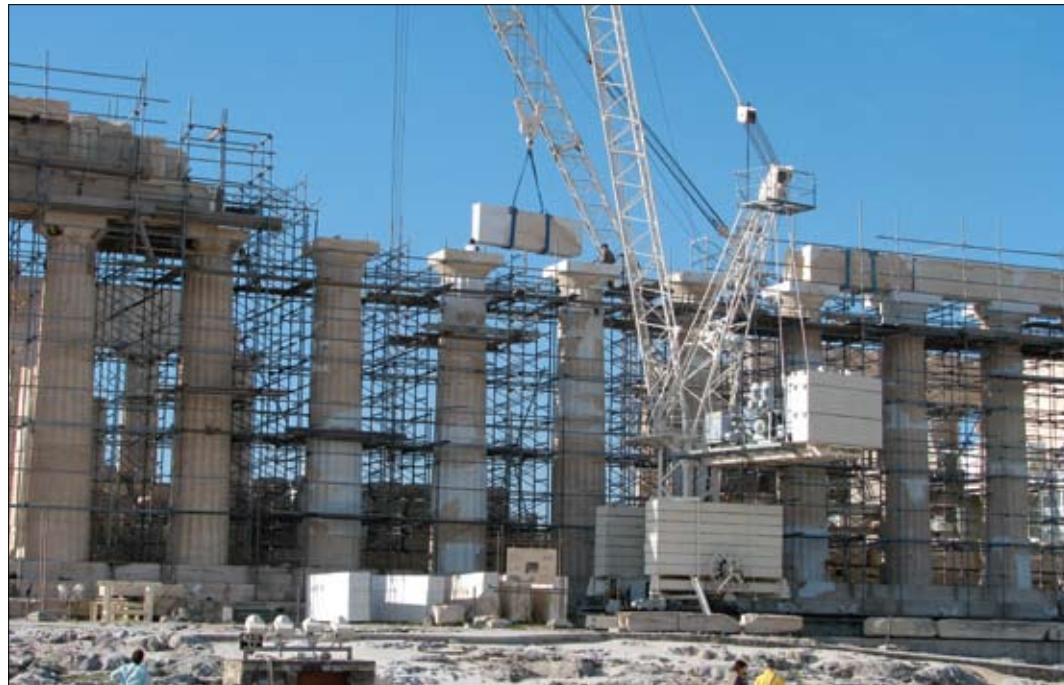
36

36. Parthenon. Resetting an architrave block of the north side. View from the north.

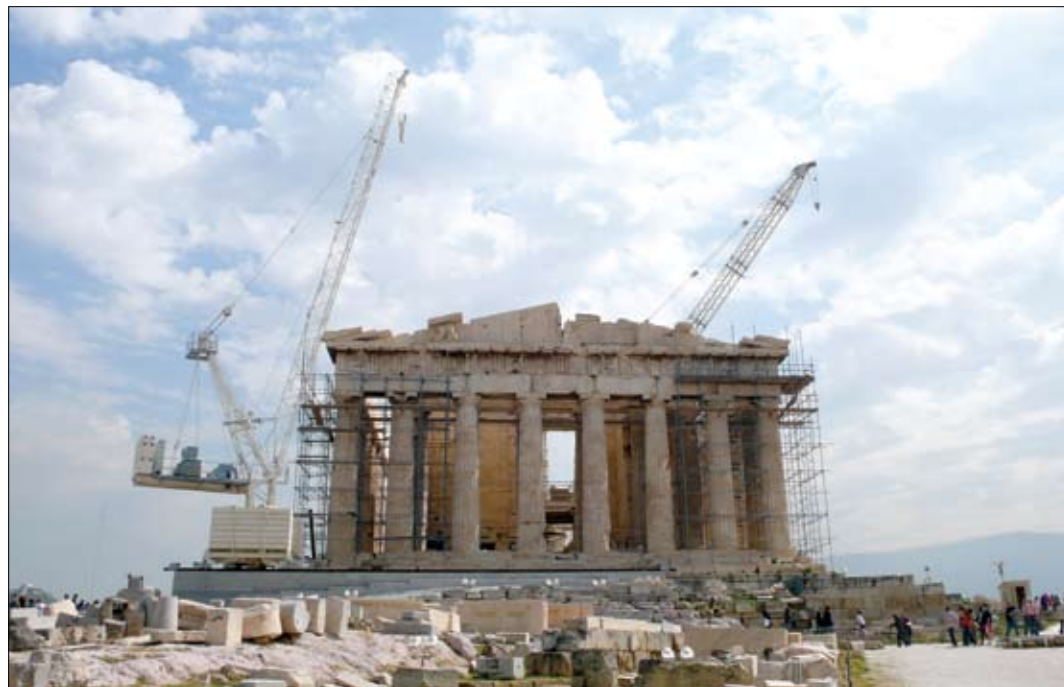
40

40. Parthenon. Restoration works at the two corners of the entablature of the west side.

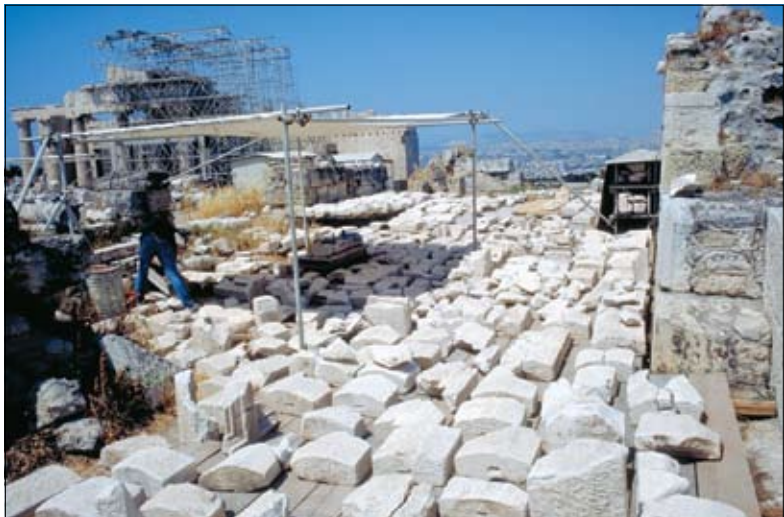
49

49. Fragments of the coffered slabs identified during research in the Propylaia worksite.

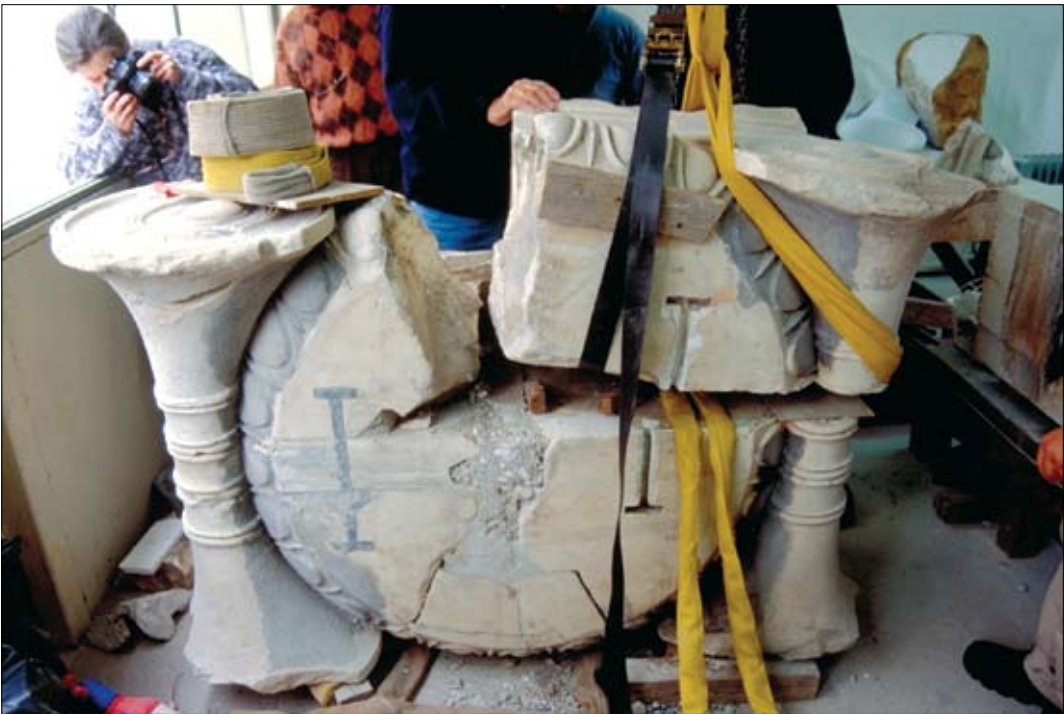
50. Dismantling the column capital of the Balanos anastelosis in the Propylaia laboratory.

by the two Ionic capitals that have been restored in the west hall, one on each side of the central passageway. The column capital of the Balanos anastelosis was made up of four ancient fragments that did not belong together and it was decided therefore not to use them in the present intervention. Fragments of the capital will be displayed in a future exhibition in the Acropolis Museum. The new capitals, exact copies of the ancient originals, were carved by hand. Interventions of special significance included also the structural restoration of beam fragments belonging to the ceilings. The beams are counted among the largest of the architectural members of the Acropolis monuments for which a special computer methodology was developed. So too, the lintel in the doorway wall of the monument, one of the two stones of which was restored in situ with a special injection.

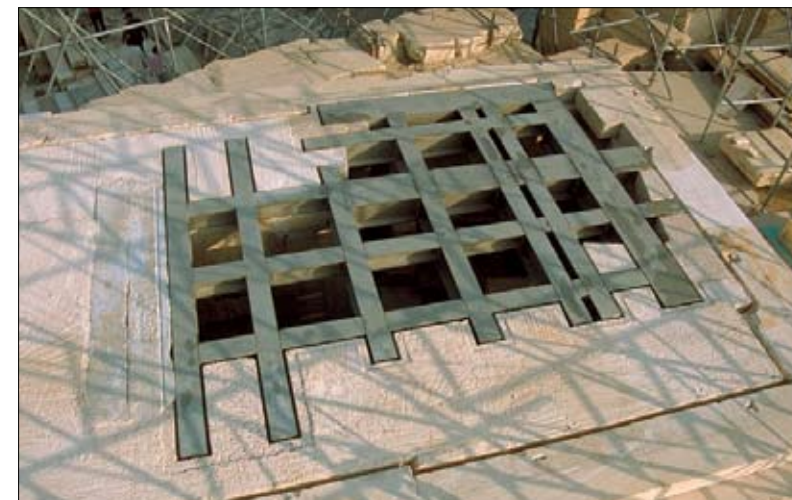
68

68. Temple of Athena Nike. The metal grid on which the temple has been placed.

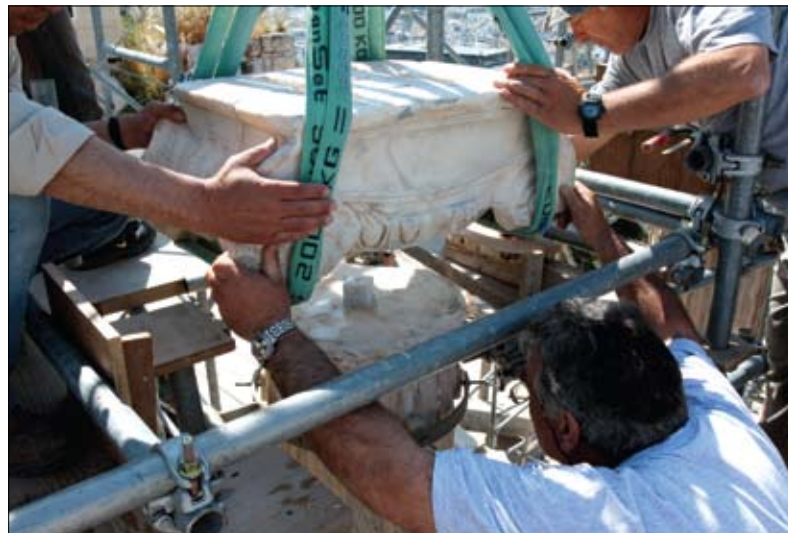
74

74. Temple of Athena Nike. Resetting a column capital in the pronaos.
