Ch. Bouras, Theoretical principles of the interventions on the monuments of the Acropolis M. Ioannidou, 2000-2007, The restoration of the Acropolis by the YSMA
F. Mallouchou-Tufano, E. Petropoulou, Public opinion poll about the restoration of the Acropolis monuments D. Englezos, Protective filling of ancient monuments. The case of the Arrephorion on the Athenian Akropolis E. Lembidaki, On the occasion of the new restoration of the temple of Athena Nike. Looking back at the history of the cult statue of Athena Nike
C. Hadziaslani, I. Kaimara, A. Leonti, The new educational museum kit "The Twelve Olympian Gods" F. Mallouchou-Tufano, News from the Acropolis
F. Mallouchou-Tufano, The restoration of the Erechtheion: 20 years later

## 7 • July 2007

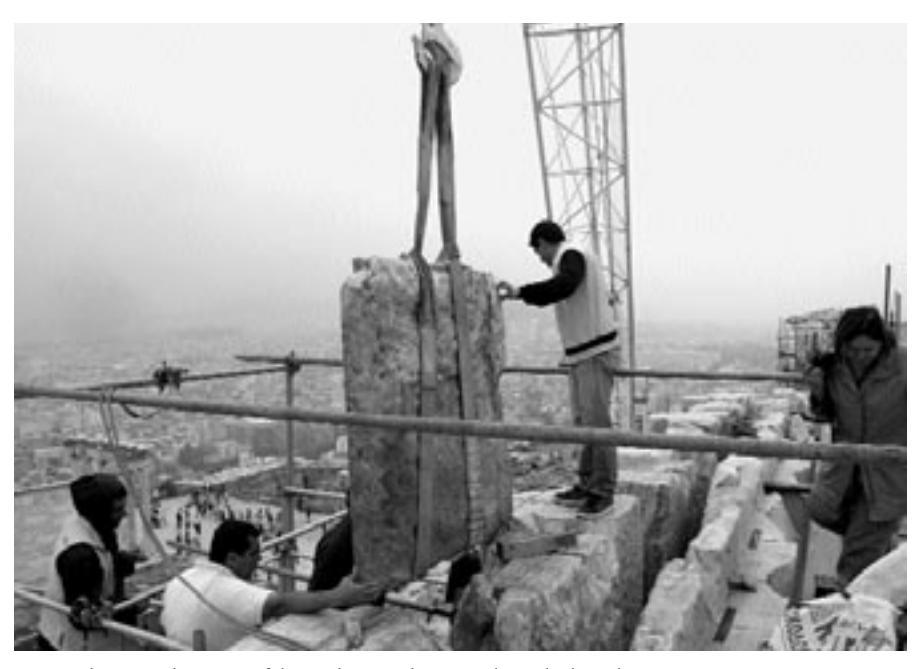
Dismantling a north metope of the Parthenon. Photo R. Christodoulopoulou, 2007

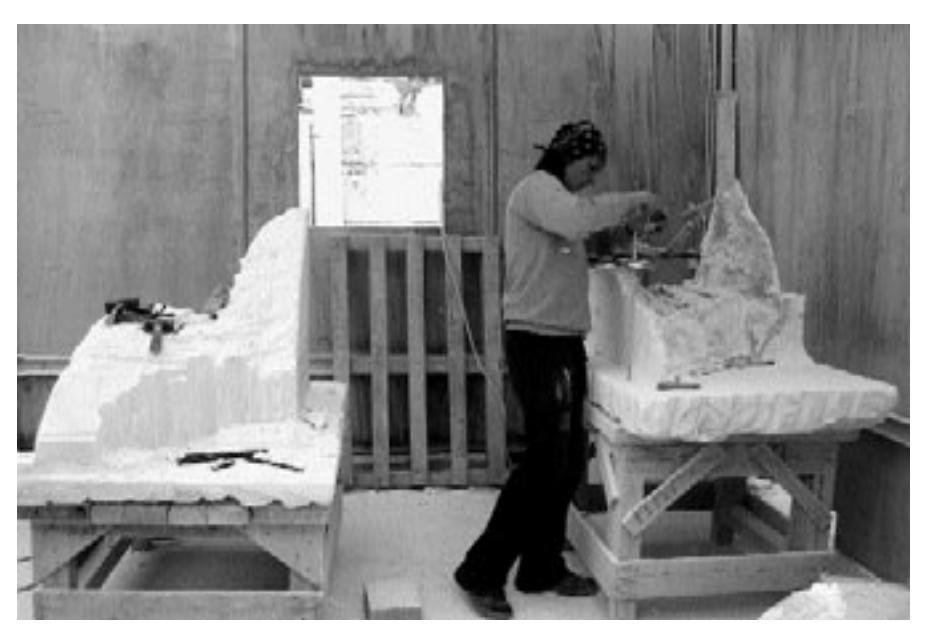
Making the new marble filling for an architectural member of the Parthenon, using the pointing device. Photo F. Mallouchou-Tufano, 2006

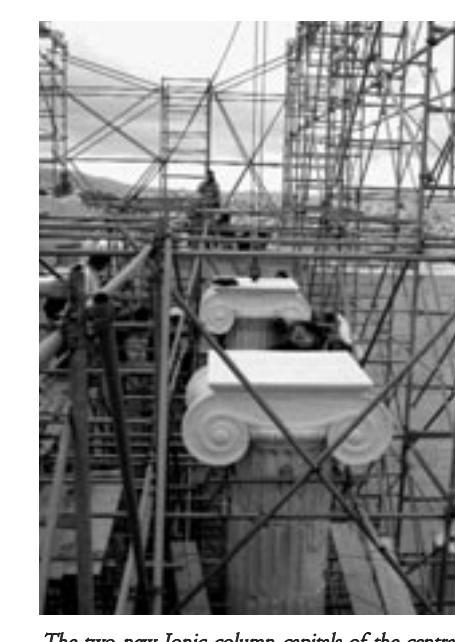
The two new Ionic column capitals of the central building of the Propylaia restored and in place. Photo E. Petropoulou, September 2006

Among the members of new marble set in place on the monument in the present anastelosis a place of honour is held by the two Ionic column capitals that were restored to the west hall either side of the central passageway. The capital of the previous anastelosis, which had been composed from four ancient fragments that did not belong together, has been kept in the Acropolis Museum. The capitals of new marble, exact copies of the ancient prototypes, were carved by hand by the marble technicians of the Propylaia. In a few months, when the anastelosis will have been finished, the entrance to the interior of the Acropolis along the central passage through the Propylaia, between the two Ionic columns, will enable visitors to have the unique experience of the roofed space of one of the most impressive monuments of classical antiquity.

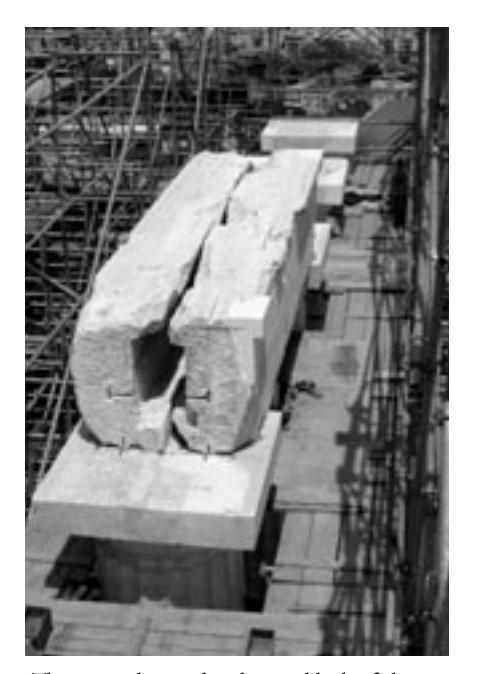
The restored central architrave block of the east portico of the Propylaia. Photo T. Tanoulas, 2003

The partial restoration of the north wall of the central building and the east portico was in essence a work that was inserted into the programme of restoring the ceilings of the Propylaia, when it was realized, after the overlying members were dismantled, that the intervention of 1909-1917 had included a significant number of blocks in those parts of the monument. The earlier intervention had in all probablility extended to the north wall in order to reduce the deformations that were caused by the great explosion of the 17th century. This

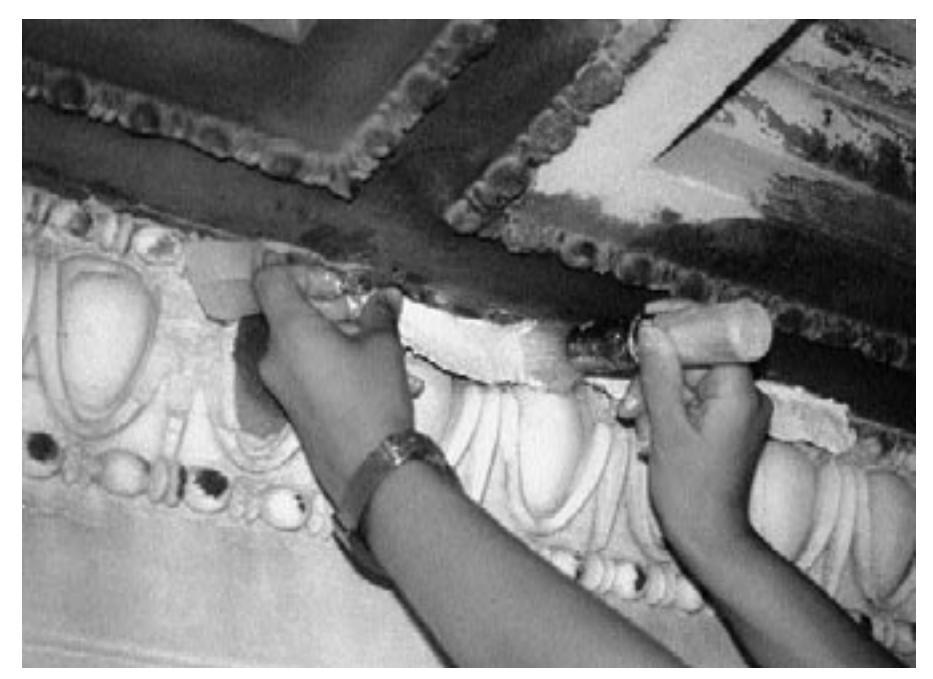
Conservation of the interior face of the ceiling of the north porch of the Erechtheion. Photo G. Frantzi, 2002

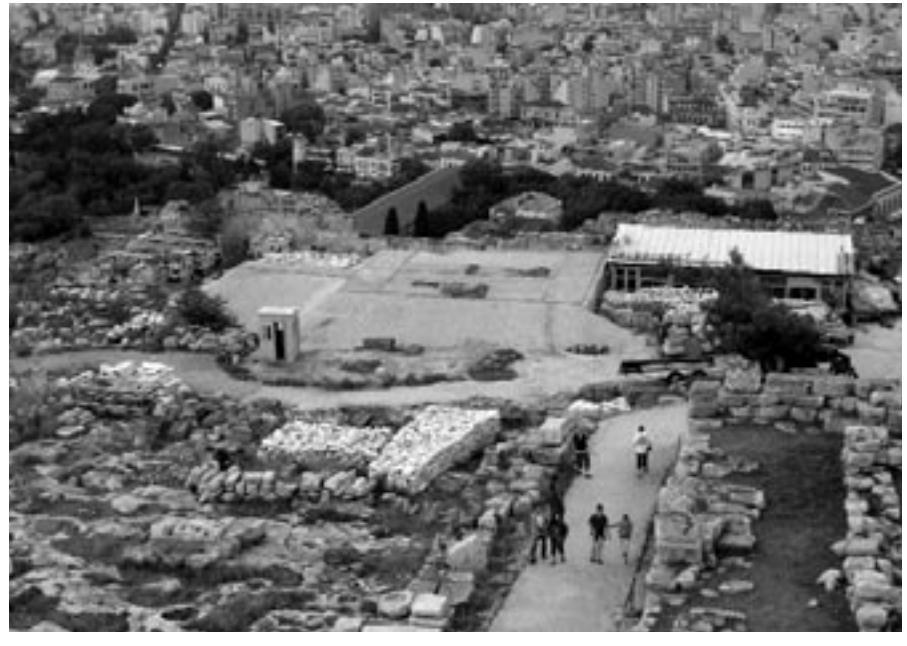
General view of the House of the Arrephoroi after reburial. Photo M. Ioannidou, June 2007

The Acropolis Restoration Service decided to backfill the foundations of the House of the Arrephoroi, the remains of which had been found northwest of the Erechtheion and against the north Acropolis Circuit Wall, in order to protect its fragile poros foundations. The work was completed in May 2007.

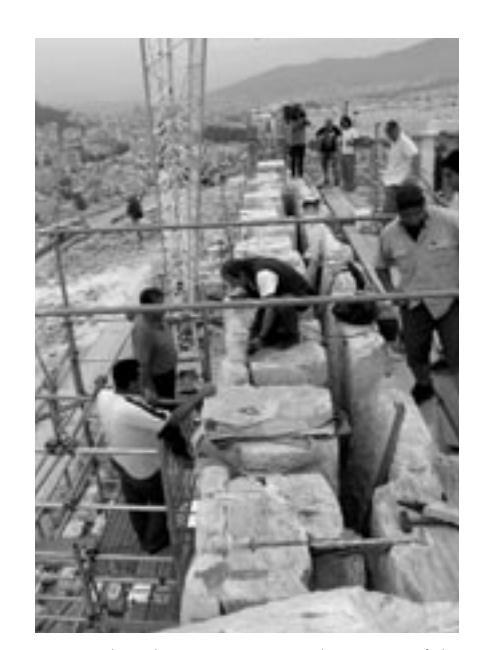
Dismantling the westernmost north metopes of the Parthenon. Photo R. Christodoulopoulou, 2007

In February 2007, the Central Archaeological Council approved the removal of the seven westernmost metopes of the north side of the Parthenon, still in situ, in order to better protect them in the Acropolis Museum. It is planned to replace them on the monument, according to the usual practice, with cast copies. The intervention planned includes as well the removal and structural restoration of four already restored cornice blocks, four filling stones, one triglyph and, in addition, the structural restoration of all the underlying members. With the conservation of the metopes completed in situ, work has begun on removing them. The process of making their cast copies is under

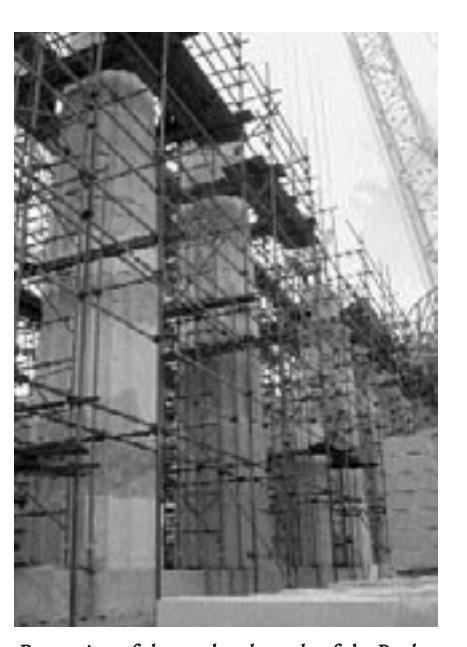
Restoration of the north colonnade of the Parthenon. View from the northeast. Photo L. Lambrinou, 2006

toration of eight columns (from the 4th to the 11th from the east) and the corresponding area of the overlying entablature. The intervention began in October 2001 with the dismantling of eight columns and the corresponding entablature blocks (a total of 230 members, weighing 900 tons) by means of a crane that was installed for this purpose outside the monument. Then came the removal of the rusted clamps and dowels and the replacement of the reinforced cement, introduced in the older intervention, with fillings of new marble. In resetting the members, the iron clamps and dowels are replaced by similar ones in titanium, and all

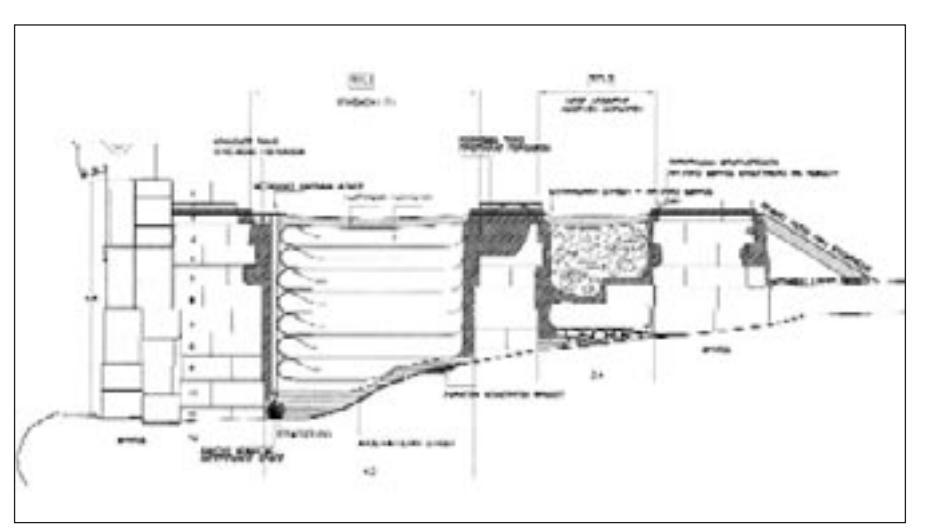
The House of the Arrephoroi. Section N-S. Drawing by V. Manidaki, 2006

The Arrephorion (House of the Arrephoroi), on the north side of the Acropolis next to the Circuit Wall, was a cult building dedicated to the goddess Athena. The preserved parts of the building include the foundation walls, which form two underground halls. The dimensions of the central hall (YTI 1) are 8.30 x 4.30 sq. m and the maximum height of the foundation 4.90 m. The smaller hall, that is the porch  $(Y\Pi 2)$ ,

measures 8.30 x 2.30 sq. m and the maximum height of the foundation wall is 3.00 m. The foundation walls, which are rectangular blocks of poros-stone (brittle marl limestone from Piraeus), range between 1.40 and 2.00 m in thickness.

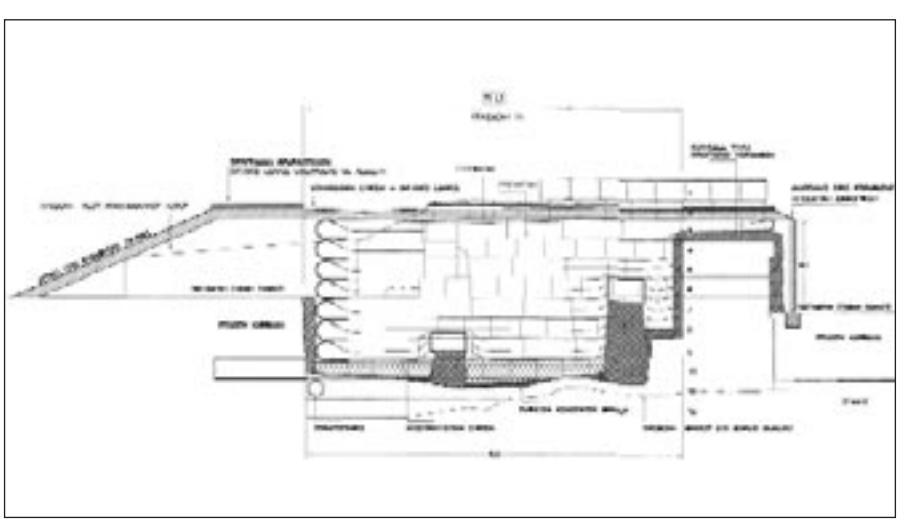
The House of the Arrephoroi. Section E-W. Drawing by V. Manidaki, 2006

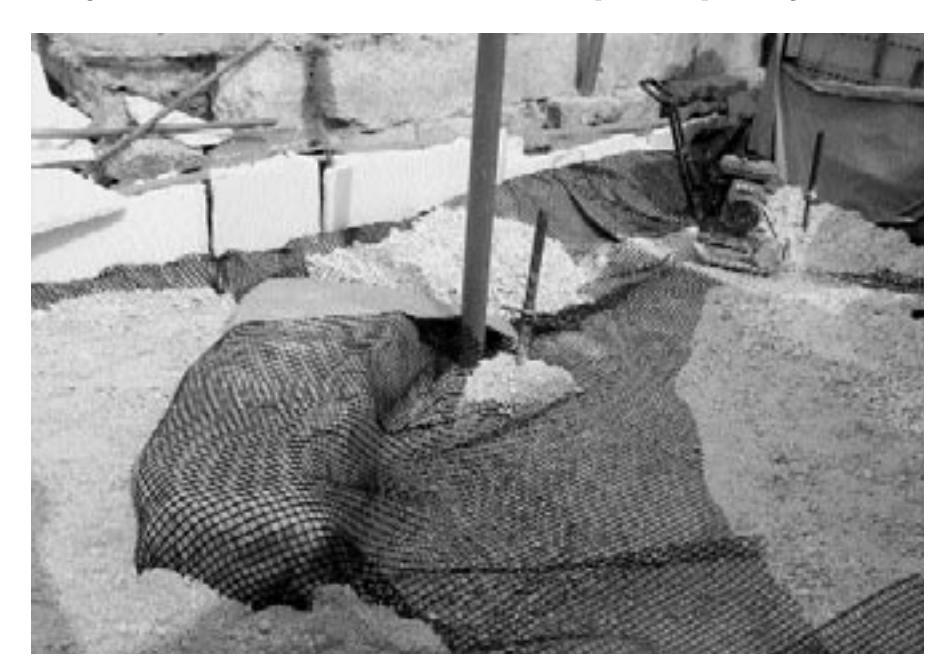
The House of the Arrephoroi. Construction of reinforced embankment with wrap around face formation. Photo D. Englezos, November 2006

6. A reinforced embankment was made on the separation geotextile with successive lavers of compacted select gravel (at least 95% of the modified Procter test), 25 cm thick and geomesh. The layers of geomesh are set at intervals of 50 cm (each two lavers of fill), with the main tensile strength oriented N-S. The façade of the fill is formed by a geomesh wrap-around, and the encasement of the ground material with the placing of a separation geotextile within the part of the geomesh that is wrapped around. Particularly in the areas of contact between the fill and the foundation walls light compaction was applied in order to lessen the lateral compaction pressures on the foundation walls. In the areas of contact between the

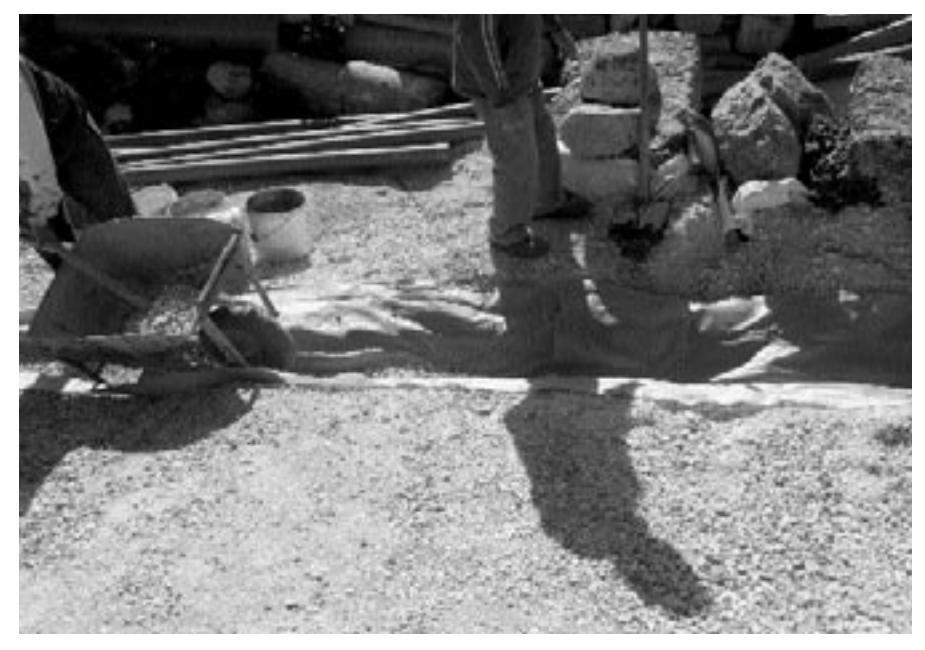
The House of the Arrephoroi. Perimetric drain to carry off rainwater. Photo D. Englezos, March 2007

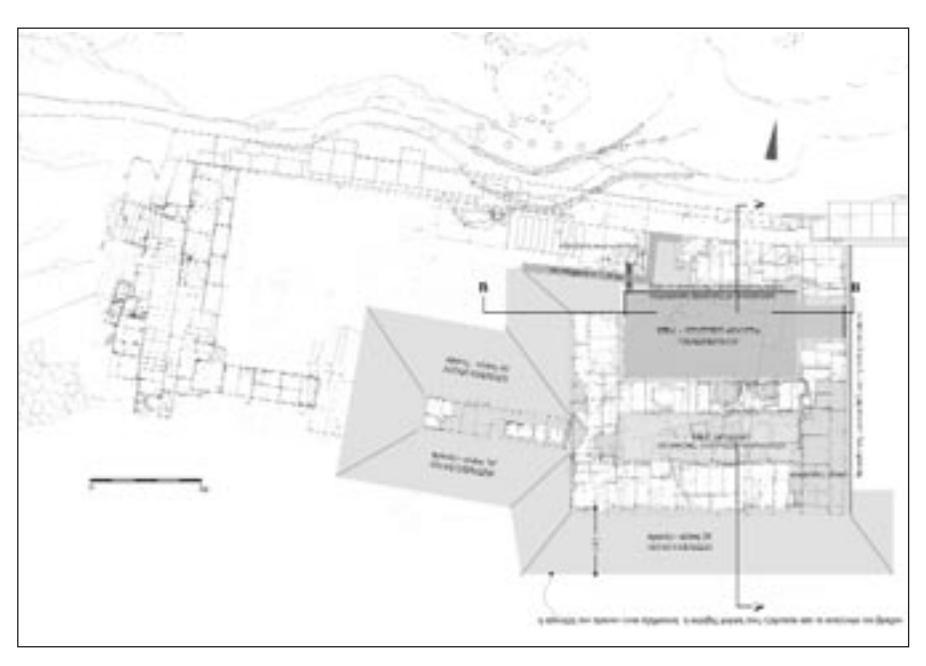
Plan of the backfilling of the Arrephorion. Drawing by V. Manidaki, 2006.

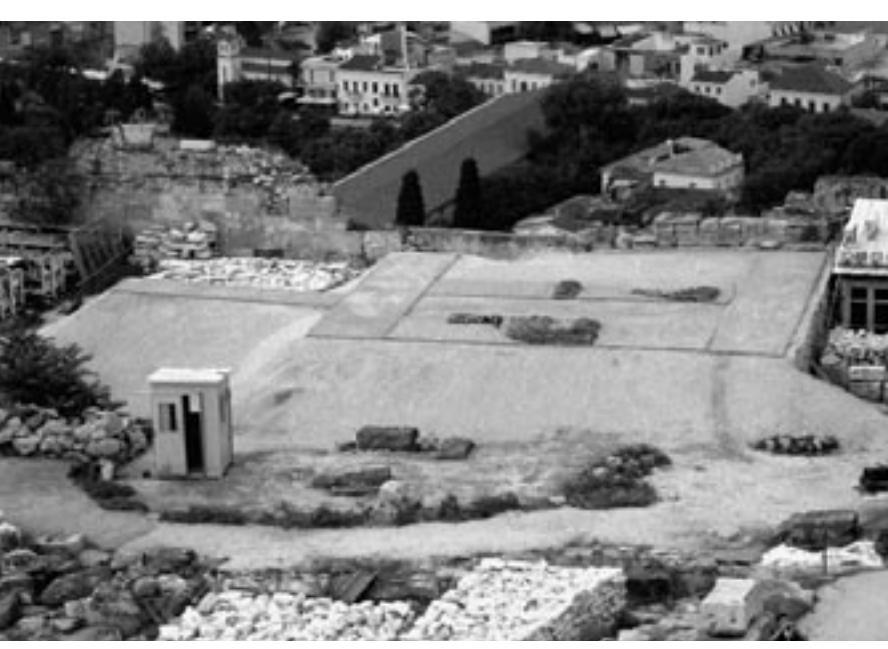
The Site of the House of the Arrephoroi after its backfilling. Photo F. Mallouchou-Tufano, May 2007

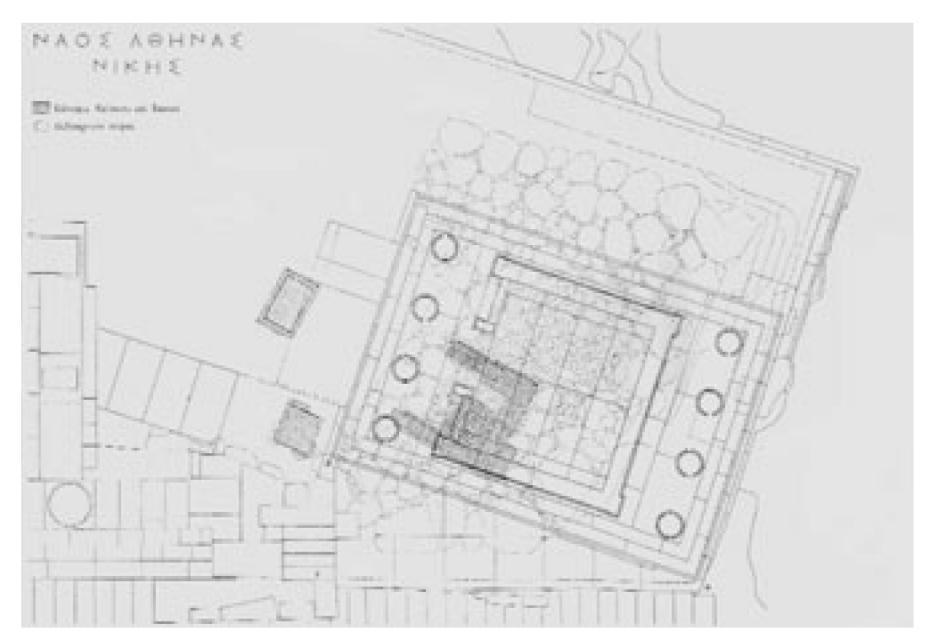
Plan of the pyrgos of Athena Nike showing the Mycenaean fortifications, the first stone shrine and the classical temple. Drawing by V. Douras, Archive of the Archaeological Society at Athens

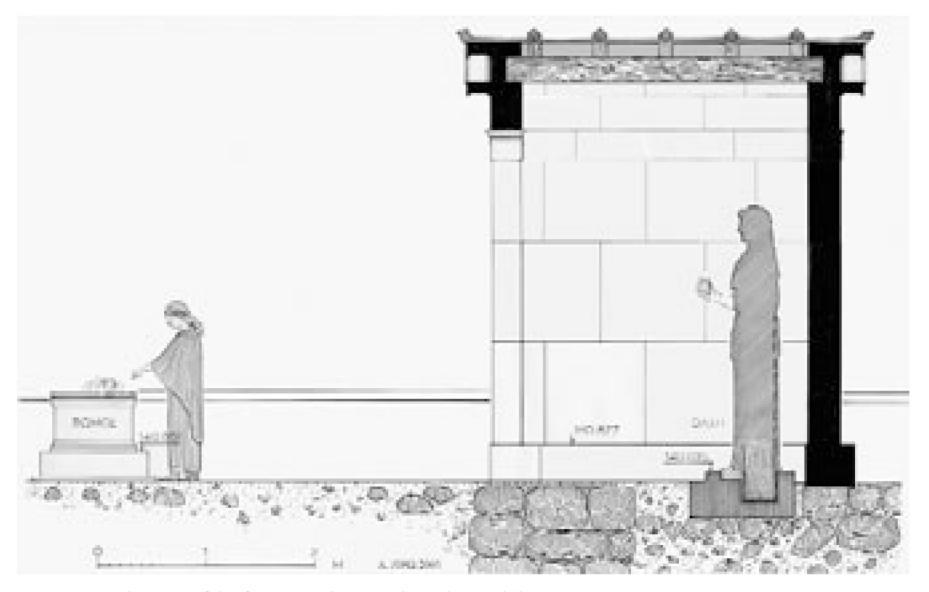
Restoration drawing of the first stone shrine with its altar and the statue. Long section. Drawing by D. Giraud, 2002

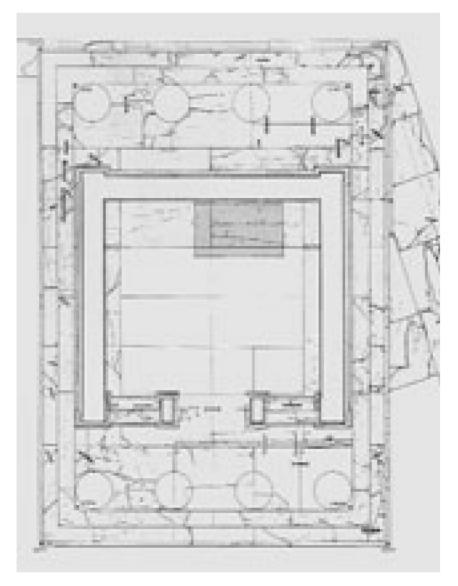
Plan of the temple of Athena Nike showing the position of the cult statue. Drawing by D. Giraud, 1994

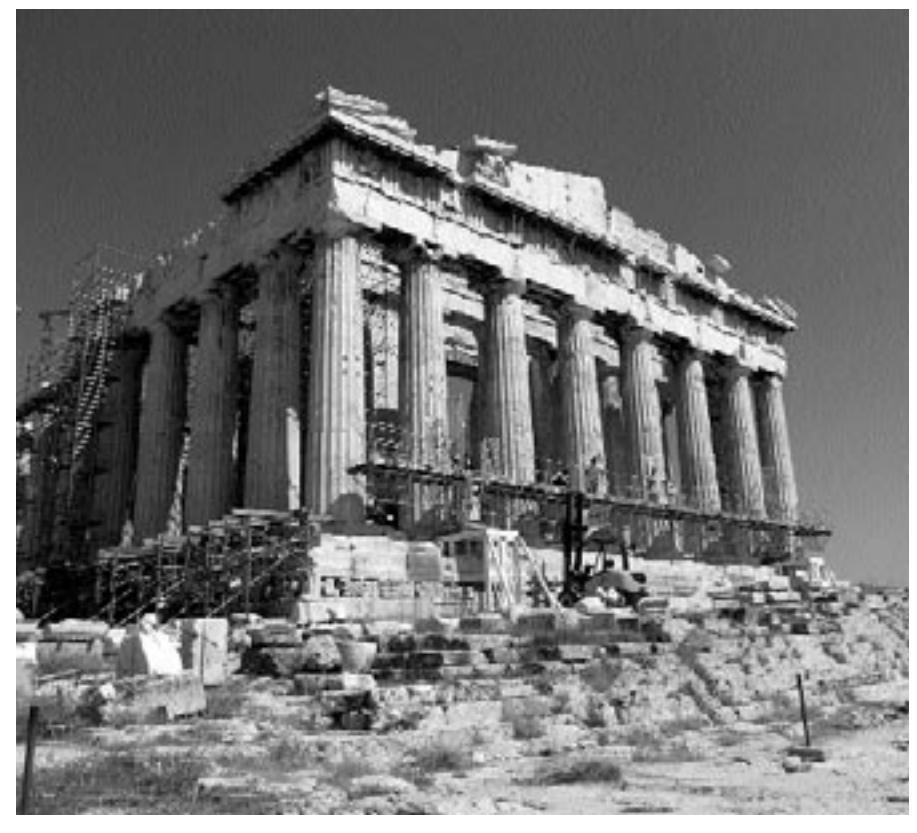
The west façade of the Parthenon with the twin mast self lifting platform for inspection and study. Photo M. Ioannidou, June 2007
