## WHY ARE THERE SO MANY CRANES AND SO MUCH SCAFFOLDING ON THE ACROPOLIS?

## WHY ARE SOME ARCHITECTURAL MEMBERS TEMPORARILY REMOVED FROM THE MONUMENTS?

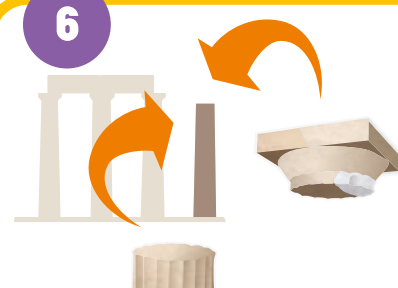
6

Scattered ancient members which have been identified are often restored and integrated into the ancient monument. These are placed in their original, or a corresponding, position. Finally, the restored architectural members are then **repositioned** on the monuments, in the positions they held in antiquity.

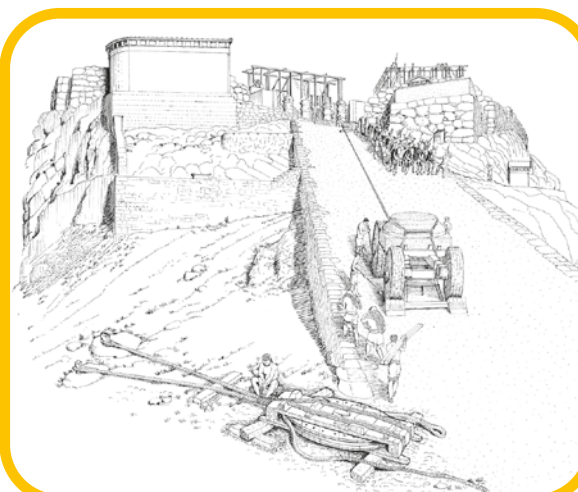
The transportation of the marble blocks from the quarry to the construction site was undertaken with **four-wheeled carts** that were pulled by many pairs of mules or oxen. The loads were raised onto hills such as the Acropolis using ramps, with the assistance of **special pulley systems** that utilized animal power.
