THE RESTORATION OF THE MONUMENTS OF THE ATHENIAN ACROPOLIS

MINISTRY OF CULTURE AND TOURISM - ACROPOLIS RESTORATION SERVICE

2nd Edition (updated with the restotation programme 2011-2013)

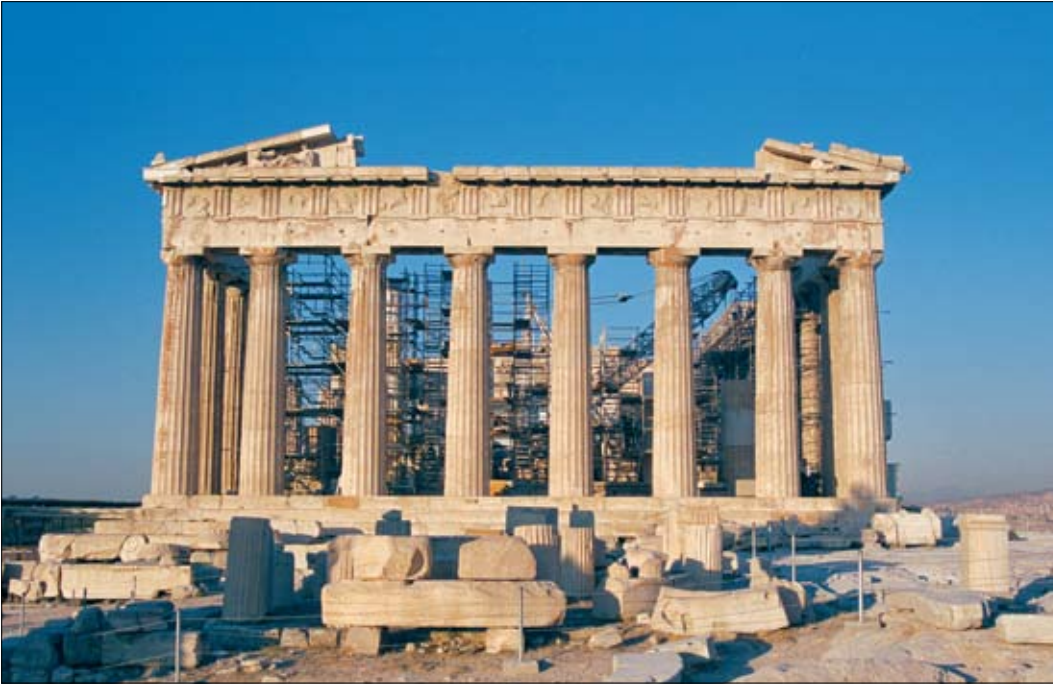
3

3. The Parthenon after the restoration of the east side. View from the east.

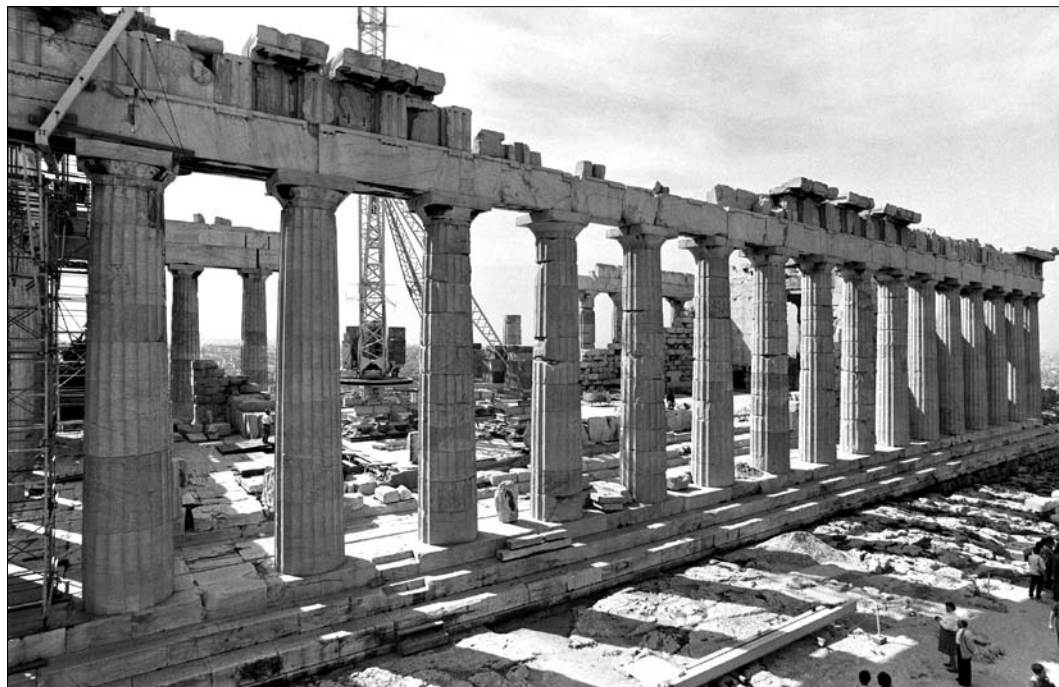
29

29. Parthenon. The north side before restoration. View from the northeast.

The very serious intervention on the **north side** of the Parthenon, where the explosion of 1687 had caused eight columns with the corresponding overlying entablature in the middle part of the colonnade to collapse, had been carried out during the years 1922-1931 under Balanos with a full anastelosis of the colonnade and a partial anastelosis of the entablature. The serious structural problems of this anastelosis (iron reinforcing, cement fillings) made a new intervention compulsory.

The purpose of the programme for restoring the north side –the most extensive ever undertaken on the monument– was to remove the rusted iron reinforcements that had been used for joining the members, to restore structurally the broken marble members and to remove wrongly placed architectural members, finding their authentic positions. During the period 2001-2003, eight middle columns of the north side (from the 4th to the 11th from the east) were entirely dismantled together with the corresponding areas of the overlying entablature. In 2007 it was considered necessary to extend the intervention to the west section of the entablature of the north side, so as to remove to the Acropolis Museum six authentic metopes in order to be protected. The metopes were replaced on the monument with copies in artificial stone.

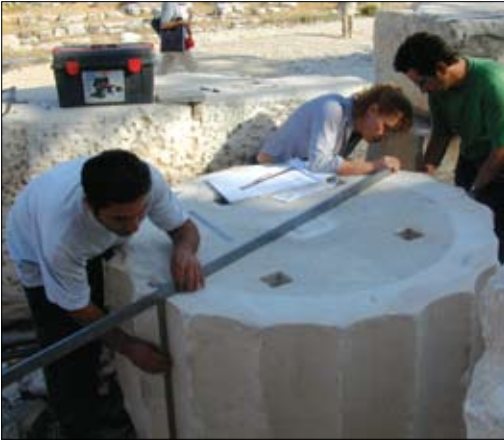
32

32. Measuring a drum of the Parthenon north colonnade.

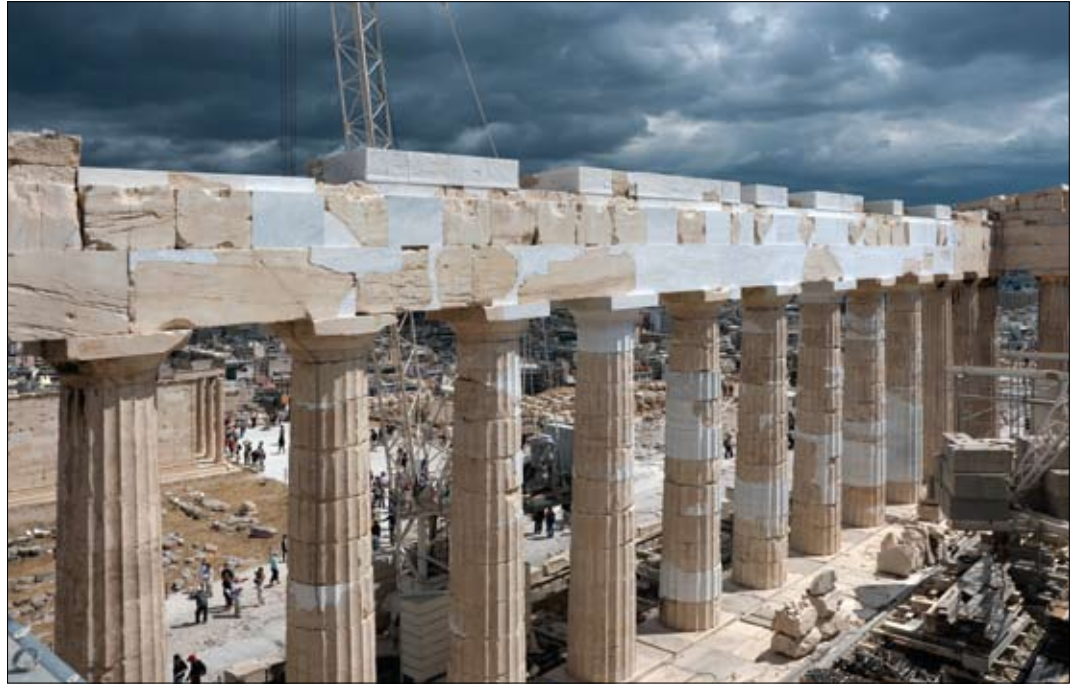
39

39. Parthenon. Interior view of the north side with restoration completed. View from the southwest.

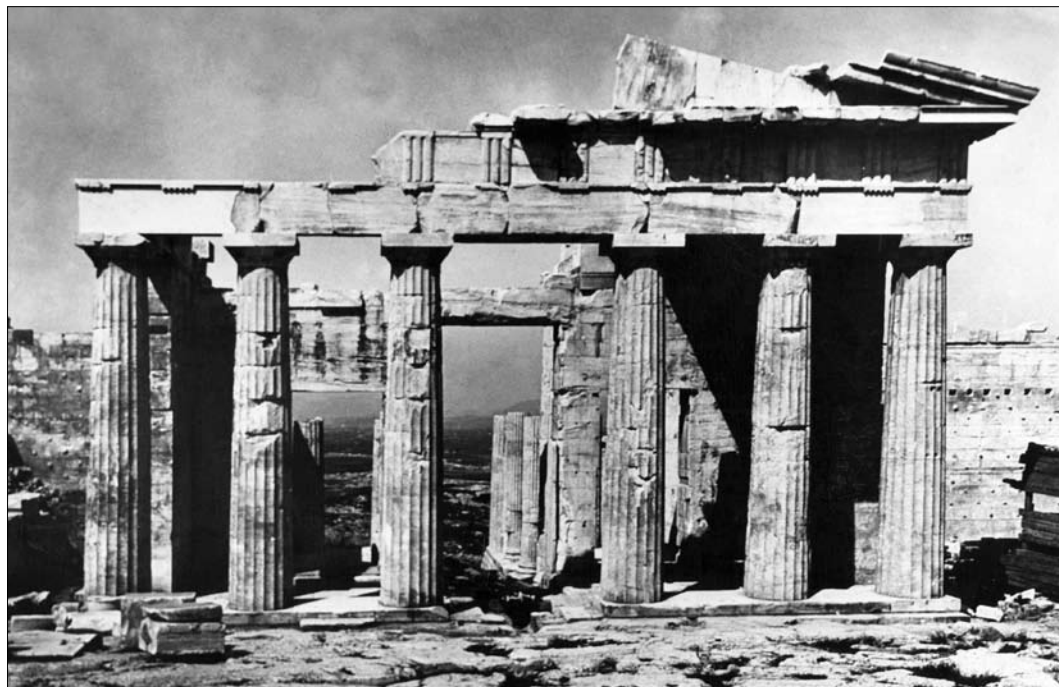
45

45. Propylaia. The east stoa after the Balanos anastelosis. View from the east.

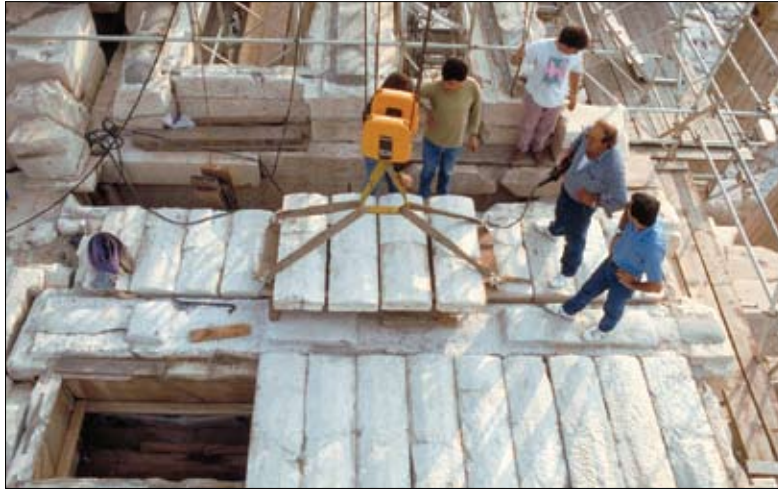
47a-b. Identification of fragments of the coffered slabs in the Propylaea worksite.

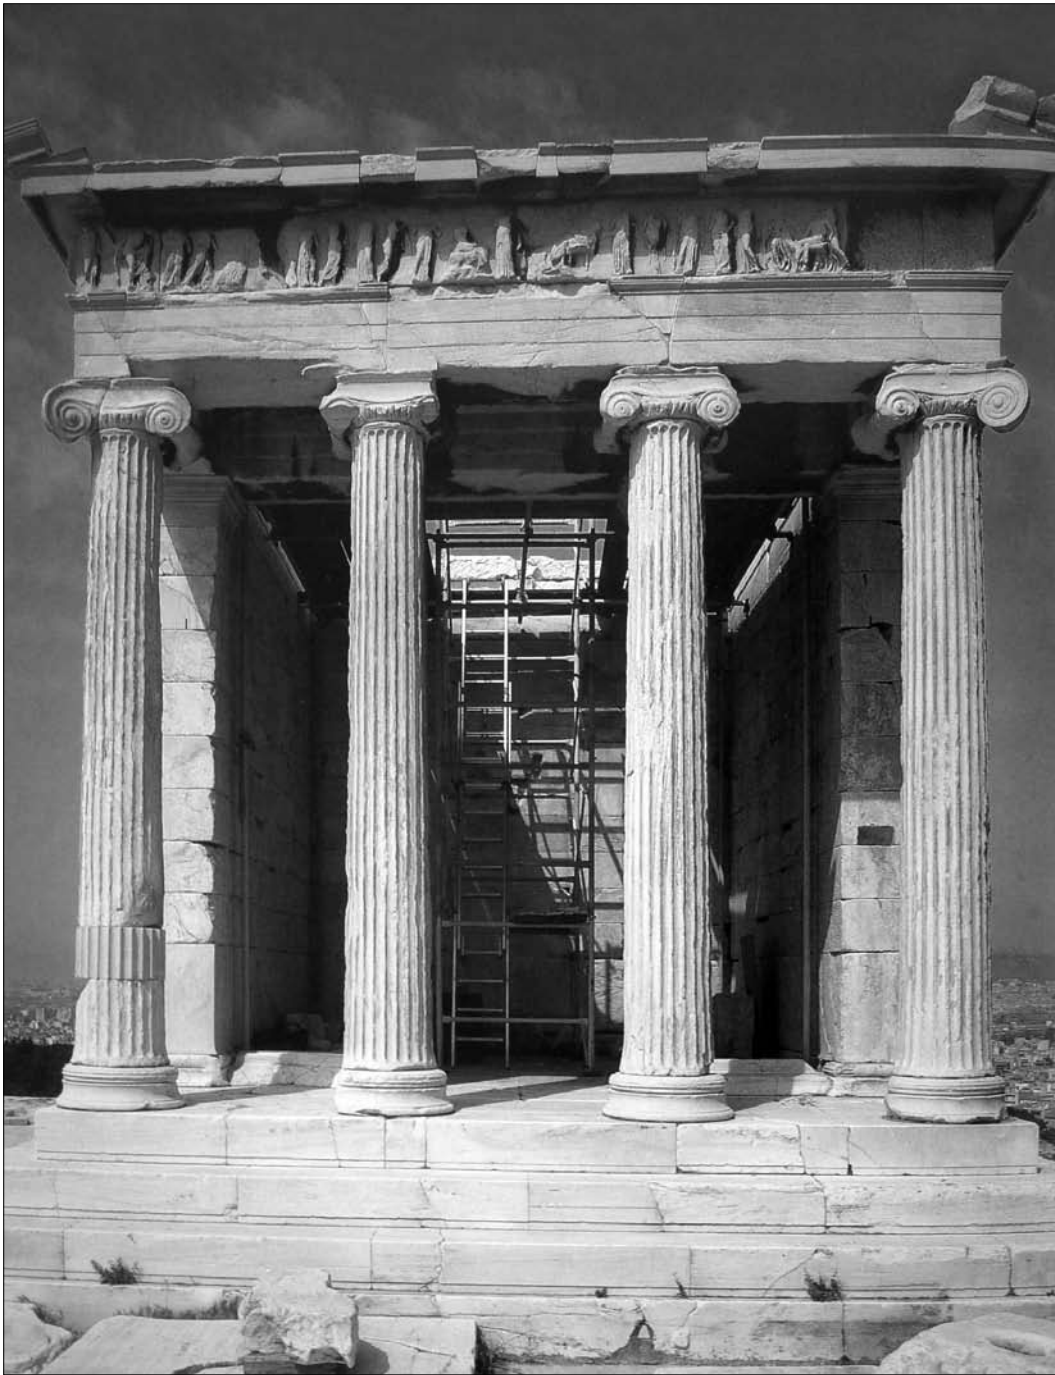
61. The temple of Athena Nike after the Balanos-Orlandos anastelosis. View from the east.

Hansen and K. Pittakis, and it involved that part of the building that had been demolished during the 17th century. The second anastelosis of 1935-40 by N. Balanos and A. Orlandos included the entire temple and most of the bastion. The serious damage and structural problems of the monument, after the earlier interventions, necessitated its third restoration with complete dismantling of its members.

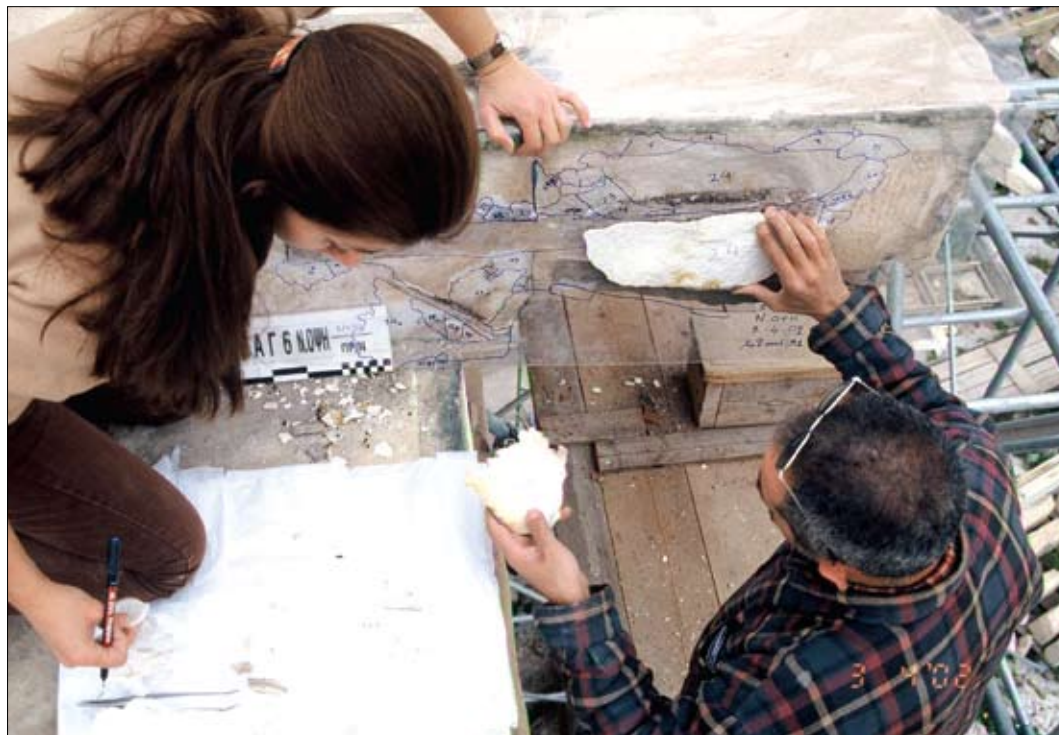
80

80. Conservation work on the surface of a cornice block of the Propylaea.

- Works of **surface conservation** were carried out on all the monuments of the Acropolis, on areas where anastelosis is under way and on other areas of the monuments as well, wherever the surfaces have serious problems of erosion. Among the most important works on the Parthenon was the conservation and cleaning of the sculptured surface of the west frieze, the purpose of which was to repair the damage it had suffered during its long history on the monument. The intervention began with the structural restoration of the blocks. The cleaning of the blocks from the soot deposits and black crust that had covered them was a most sensitive and delicate operation, since in the process the historical layers of the surface of the sculpture had to be preserved and retained, as they hold valuable information about the original workmanship and polychrome. The cleaning method chosen as the most permissible was the laser in an entirely original application, using simultaneously two wave lengths, ultrared and ultraviolet. It was developed after research in collaboration of the YSMA with the Institute of Electronic Structure and Laser of the Foundation for Research and Technology (FORTH). The works were carried out during the period 2002-2004 with excellent results. With this system, soot deposits and carbon and all types of black crust were safely removed without affecting the underlying layer of marble and coloured layers preserved on the sur-

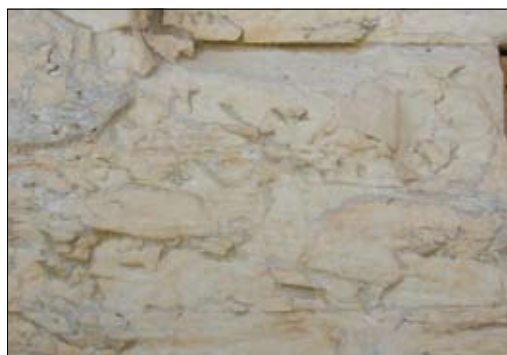
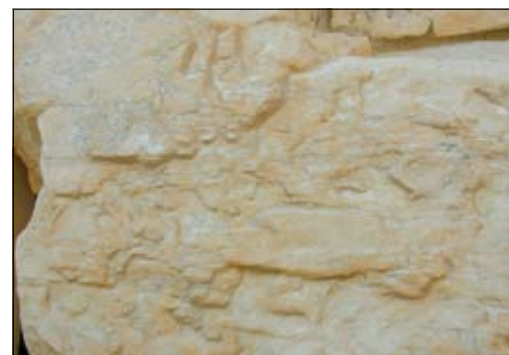
81a-b. Conservation work on the surface of the south wall of the Erechtheion. Condition of the surface before and after the interventions.
